Access Compliance Report

Public Rights-of-Way

(Curb Ramps)

Intersection ID: 24485	Main Street: CAMAROSS_DR	Cross Street: SAINTFIELD_PL	Location: NE
ADA ID: BACF8261F1BD	Ramp Type: Perp	Initial Pass/Fail: Fail	Overall Compliance: No
Severity Score: 22.5			
Codes/Mitigation Info/Possible Solution		Field Measurements/Component Compliance

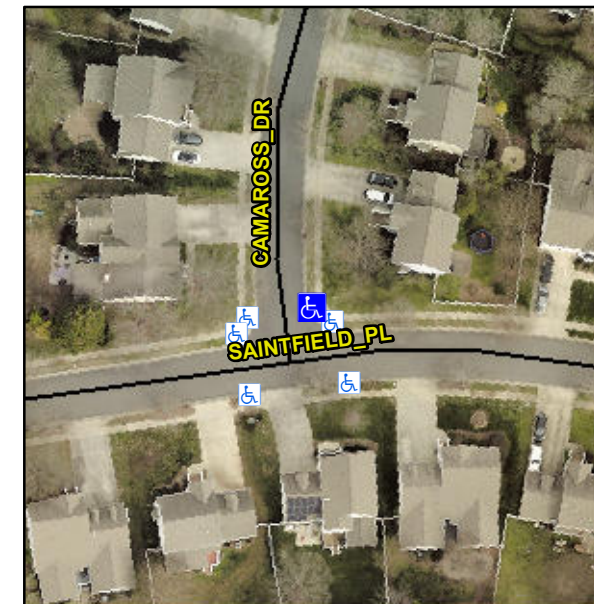
R304.5.1, R304.2.2, R304.5.3

Compliance	Description	Data	Compliance	Description	Data
N/A	Ramp Length (in)	46.0	No	Ramp Slope (%)	8.9
No	Ramp Width (in)	39.0	No	Ramp XSlope (%)	4.0
N/A	Flare Type LT	N/A	N/A	Flare Type RT	N/A
N/A	Flare Slope LT (%)	N/A	N/A	Flare Slope RT (%)	N/A
N/A	Flare Traversable LT?	N/A	N/A	Flare Traversable RT?	N/A
N/A	Landing Length (in)	N/A	N/A	DWS Provided?	N/A
N/A	Landing Width (in)	N/A	N/A	DWS Contrast?	N/A
N/A	Landing Slope (%)	N/A	N/A	DWS Length (in)	N/A
N/A	Landing X Slope (%)	N/A	N/A	DWS Full Width?	N/A
N/A	Landing Curb? (Y/N)	N/A	N/A	DWS Offset (in)	N/A
N/A	Shared Landing?	N/A			
N/A	Gutter Ponding?	N/A	N/A	Gutter Slope (%)	N/A
N/A	Gutter Lip Ht (in)	N/A	N/A	Gutter X Slope (%)	N/A
N/A	Painted X Walk1?	No	N/A	Painted X Walk2?	N/A
	X Walk 1 Direction	To W		X Walk 2 Direction	N/A
N/A	X Walk 1 Width (in)	N/A	N/A	X Walk 2 Width (in)	N/A
	X Walk 1 Slope (%)	0.8		X Walk 2 Slope (%)	N/A
	X Walk 1 X Slope (%)	2.2		X Walk 2 X Slope (%)	N/A

N/A	Ramp inside XWalk1?	N/A	N/A	Ramp inside XWalk2?	N/A
	Road Slope (%)	N/A	N/A	Clear Space?	N/A
	Road X Slope (%)	N/A	N/A	Clear Space to XWalk (in)	N/A
N/A	Any Obstructions?	N/A	N/A	Storm Grate/Utility Hazard?	N/A
	Obstruction Type			Storm Grate/Utility Type	
		N/A			N/A
			Yes	Surface Condition? (G/P)	Good

Remove & Replace Entire Ramp.
