Access Compliance Report Public Rights-of-Way (Curb Ramps)

Intersection ID: 30070 Main Street: SOUTHWIND_DR Cross Street: WATERS_TRAIL_DR Location: NE

ADA ID: BADA8CEC4627 Ramp Type: BlendTrans1 Initial Pass/Fail: Fail Overall Compliance: No Severity Score: 12.5

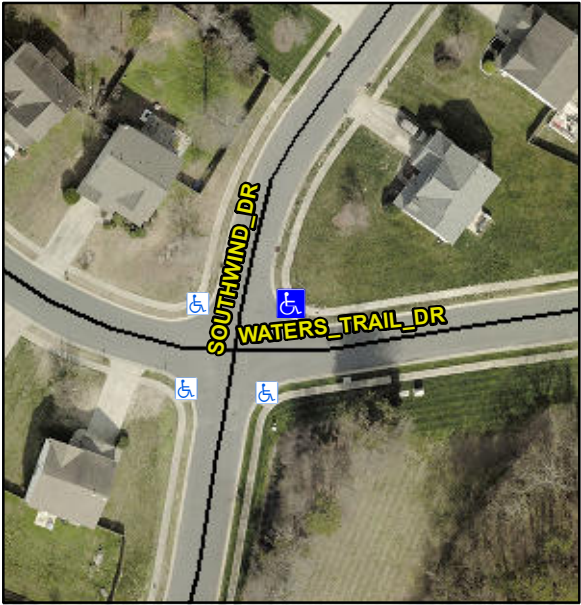
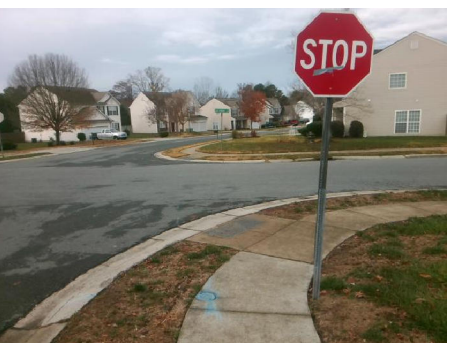
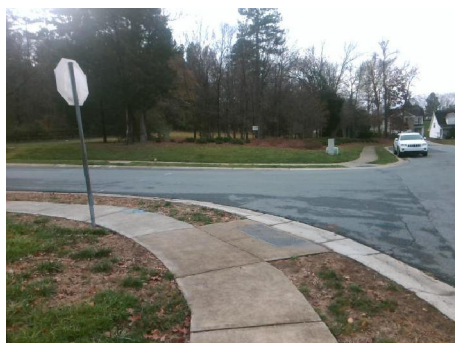
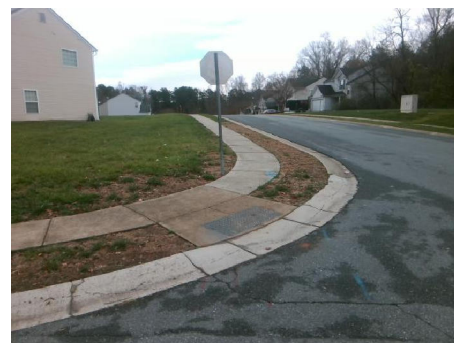
PROW/ADA:
Not Found, R304.5.3

Compliance	Description	Data	Compliance	Description	Data
N/A	Ramp Length (in)	49.5	Yes	BlendTrans Slope (%)	4.8
Yes	Ramp Width (in)	48.5	No	BlendTrans XSlope (%)	5.5
N/A	Flare Type LT	N/A	N/A	Flare Type RT	N/A
N/A	Flare Slope LT (%)	N/A	N/A	Flare Slope RT (%)	N/A
N/A	Flare Traversable LT?	N/A	N/A	Flare Traversable RT?	N/A
N/A	Landing Length (in)	N/A	N/A	DWS Provided?	N/A
N/A	Landing Width (in)	N/A	N/A	DWS Contrast?	N/A
N/A	Landing Slope (%)	N/A	N/A	DWS Length (in)	N/A
N/A	Landing X Slope (%)	N/A	N/A	DWS Full Width?	N/A
N/A	Landing Curb? (Y/N)	N/A	N/A	DWS Offset (in)	N/A
N/A	Shared Landing?	N/A			
N/A	Gutter Ponding?	N/A	N/A	Gutter Slope (%)	N/A
N/A	Gutter Lip Ht (in)	N/A	N/A	Gutter X Slope (%)	N/A
N/A	Painted X Walk1?	No	N/A	Painted X Walk2?	No
	X Walk 1 Direction	To W		X Walk 2 Direction	To S
	X Walk 1 Width (in)	N/A		X Walk 2 Width (in)	N/A
	X Walk 1 Slope (%)	0.2		X Walk 2 Slope (%)	0.2
	X Walk 1 X Slope (%)	1.4		X Walk 2 X Slope (%)	3.3

N/A	Ramp inside XWalk1?	N/A	N/A	Ramp inside XWalk2?	N/A
	Road Slope (%)	3.5		Clear Space?	N/A
	Road X Slope (%)	0.6	N/A	Clear Space to XWalk (in)	N/A
N/A	Any Obstructions?	N/A	N/A	Storm Grate/Utility Hazard?	N/A
	Obstruction Type			Storm Grate/Utility Type	
		N/A			N/A
Yes	Surface Condition? (G/P)		Yes		Good
No	Curb Slope (%)		No		7.0

Possible Solutions:
Remove & Replace Curb Ramp With Two New Directional Ramps or Equivalent.
