Access Compliance Report Public Rights-of-Way (Curb Ramps)

Intersection ID: 25072
 Main Street:
 CARRIAGE_LAKE_DR
 Cross Street:
 COPPER_RIDGE_TL
 Location:
 SW

ADA ID: BADF3F595C79
 Ramp Type:
 Perp
 Initial Pass/Fail:
 Fail
 Overall Compliance:
 No
 Severity Score:
 37.5

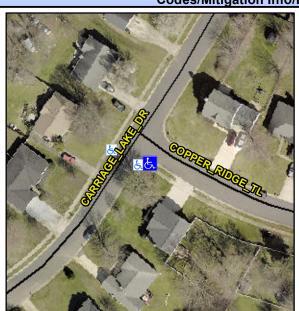
Not Found, R304.2.2, R304.5.3

Field Measurements/Component Compnance					
Compliance Description Date		Data	Compliance Description		Data
N/A	Ramp Length (in)	101.0	No	Ramp Slope (%)	10.6
Yes	Ramp Width (in)	48.0	No	Ramp XSlope (%)	7.8
N/A	Flare Type LT	N/A	N/A	Flare Type RT	N/A
N/A	Flare Slope LT (%)	N/A	N/A	Flare Slope RT (%)	N/A
N/A	Flare Traversable LT?	N/A	N/A	Flare Traversable RT?	N/A
N/A	Landing Length (in)	N/A	N/A	DWS Provided?	N/A
N/A	Landing Width (in)	N/A	N/A	DWS Contrast?	N/A
N/A	Landing Slope (%)	N/A	N/A	DWS Length (in)	N/A
N/A	Landing X Slope (%)	N/A	N/A	DWS Full Width?	N/A
N/A	Landing Curb? (Y/N)	N/A	N/A	DWS Offset (in)	N/A
N/A	Shared Landing?	N/A			
N/A	Gutter Ponding?	N/A	N/A	Gutter Slope (%)	N/A
N/A	Gutter Lip Ht (in)	N/A	N/A	Gutter X Slope (%)	N/A
N/A	Painted X Walk1?	No	N/A	Painted X Walk2?	N/A
	X Walk 1 Direction	To NE		X Walk 2 Direction	N/A
N/A	X Walk 1 Width (in)	N/A	N/A	X Walk 2 Width (in)	N/A
	X Walk 1 Slope (%)	1.8		X Walk 2 Slope (%)	N/A

X Walk 1 X Slope (%)	5.2		X Walk 2 X Slope (%)	N/A
N/A	Ramp inside XWalk1?	N/A	N/A	Ramp inside XWalk2?	N/A
	Road Slope (%)	N/A	N/A	Clear Space?	N/A
	Road X Slope (%)	N/A	N/A	Clear Space to XWalk (in)	N/A
N/A	Any Obstructions?	N/A	N/A	Storm Grate/Utility Hazard?	N/A
	Obstruction Type			Storm Grate/Utility Type	
		N/A			N/A
			Yes	Surface Condition? (G/P)	Good

Remove & Replace Entire Ramp.

Total Cost: \$ 1850.00
