Access Compliance Report

Public Rights-of-Way

(Curb Ramps)

Intersection ID: 13683	Main Street: ELIZABETH_AV	Cross Street: CHARLOTTETOWNE_AV	Location: S
ADA ID: BAE82241B9B1	Ramp Type: Perp	Initial Pass/Fail: Fail	Overall Compliance: No
Severity Score: 10			
Codes/Mitigation Info/Possible Solution		Field Measurements/Component Compliance

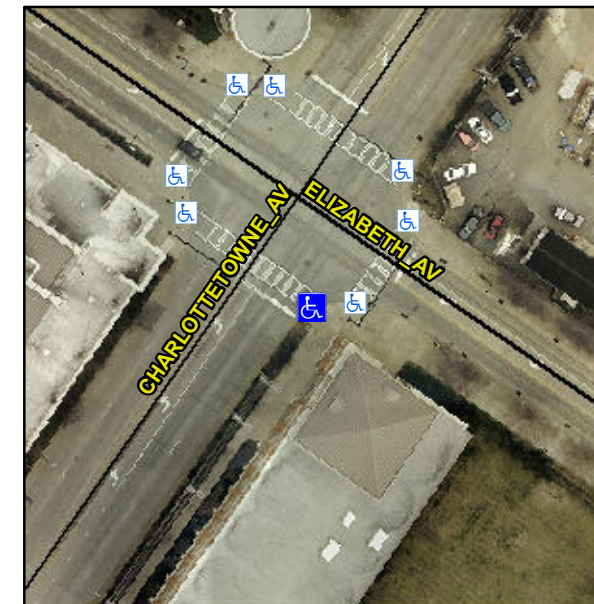
Not Found, R304.5.1, R304.5.3

Compliance	Description	Data	Compliance	Description	Data
N/A	Ramp Length (in)	84.0	Yes	Ramp Slope (%)	8.0
No	Ramp Width (in)	47.5	No	Ramp XSlope (%)	3.1
N/A	Flare Type LT	N/A	N/A	Flare Type RT	N/A
N/A	Flare Slope LT (%)	N/A	N/A	Flare Slope RT (%)	N/A
N/A	Flare Traversable LT?	N/A	N/A	Flare Traversable RT?	N/A
N/A	Landing Length (in)	N/A	N/A	DWS Provided?	N/A
N/A	Landing Width (in)	N/A	N/A	DWS Contrast?	N/A
N/A	Landing Slope (%)	N/A	N/A	DWS Length (in)	N/A
N/A	Landing X Slope (%)	N/A	N/A	DWS Full Width?	N/A
N/A	Landing Curb? (Y/N)	N/A	N/A	DWS Offset (in)	N/A
N/A	Shared Landing?	N/A			
N/A	Gutter Ponding?	N/A	N/A	Gutter Slope (%)	N/A
N/A	Gutter Lip Ht (in)	N/A	N/A	Gutter X Slope (%)	N/A
N/A	Painted X Walk1?	Yes	N/A	Painted X Walk2?	N/A
	X Walk 1 Direction	To NW		X Walk 2 Direction	N/A
N/A	X Walk 1 Width (in)	106.0	N/A	X Walk 2 Width (in)	N/A
	X Walk 1 Slope (%)	4.4		X Walk 2 Slope (%)	N/A
	X Walk 1 X Slope (%)	1.7		X Walk 2 X Slope (%)	N/A

N/A	Ramp inside XWalk1?	Yes	N/A	Ramp inside XWalk2?	N/A
	Road Slope (%)	N/A	N/A	Clear Space?	N/A
	Road X Slope (%)	N/A	N/A	Clear Space to XWalk (in)	N/A
N/A	Any Obstructions?	N/A	N/A	Storm Grate/Utility Hazard?	N/A
	Obstruction Type			Storm Grate/Utility Type	
		N/A			N/A
			Yes	Surface Condition? (G/P)	Good

Remove & Replace Entire Ramp.
