# Access Compliance Report

## Public Rights-of-Way

### (Curb Ramps)

Intersection ID: 8329	Main Street: BEATTIES_FORD_RD	Cross Street: LASALLE_ST	Location: SW
ADA ID: BAEED3D853B3	Ramp Type: Perp	Initial Pass/Fail: Fail	Overall Compliance: No
Severity Score: 8.75			
Codes/Mitigation Info/Possible Solution		Field Measurements/Component Compliance

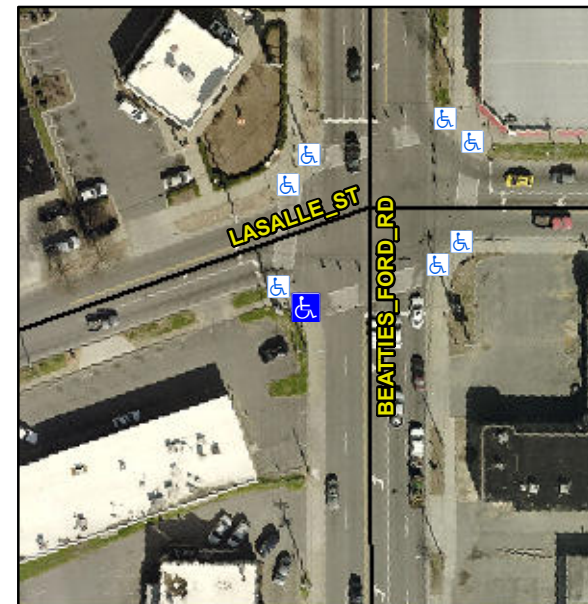
Compliance	Description	Data	Compliance	Description	Data
N/A	Ramp Length (in)	84.0	Yes	Ramp Slope (%)	7.1
No	Ramp Width (in)	44.0	Yes	Ramp XSlope (%)	1.6
N/A	Flare Type LT	N/A	N/A	Flare Type RT	N/A
N/A	Flare Slope LT (%)	N/A	N/A	Flare Slope RT (%)	N/A
N/A	Flare Traversable LT?	N/A	N/A	Flare Traversable RT?	N/A
N/A	Landing Length (in)	N/A	N/A	DWS Provided?	N/A
N/A	Landing Width (in)	N/A	N/A	DWS Contrast?	N/A
N/A	Landing Slope (%)	N/A	N/A	DWS Length (in)	N/A
N/A	Landing X Slope (%)	N/A	N/A	DWS Full Width?	N/A
N/A	Landing Curb? (Y/N)	N/A	N/A	DWS Offset (in)	N/A
N/A	Shared Landing?	N/A			
N/A	Gutter Ponding?	N/A	N/A	Gutter Slope (%)	N/A
N/A	Gutter Lip Ht (in)	N/A	N/A	Gutter X Slope (%)	N/A
N/A	Painted X Walk1?	Yes	N/A	Painted X Walk2?	N/A
	X Walk 1 Direction	To NE		X Walk 2 Direction	N/A
N/A	X Walk 1 Width (in)	120.0	N/A	X Walk 2 Width (in)	N/A
	X Walk 1 Slope (%)	3.0		X Walk 2 Slope (%)	N/A
	X Walk 1 X Slope (%)	0.3		X Walk 2 X Slope (%)	N/A

N/A	Ramp inside XWalk1?	Yes	N/A	Ramp inside XWalk2?	N/A
	Road Slope (%)	N/A	N/A	Clear Space?	N/A
	Road X Slope (%)	N/A	N/A	Clear Space to XWalk (in)	N/A
N/A	Any Obstructions?	N/A	N/A	Storm Grate/Utility Hazard?	N/A
	Obstruction Type			Storm Grate/Utility Type	
		N/A			N/A
		Yes		Surface Condition? (G/P)	Good

Possible Solutions:

**Remove & Replace Entire Ramp.**

**Not Found, R304.5.1**
