| Intersection ID: 20385 | Main Street: COOPERSDALE_RD | Cross Street: INGLEHURST_DR | Location: | NE |
| ADA ID: BAF2FA03BFE4 | Ramp Type: Perp | Initial Pass/Fail: Fail | Overall Compliance: No | Severity Score: 13.75 |

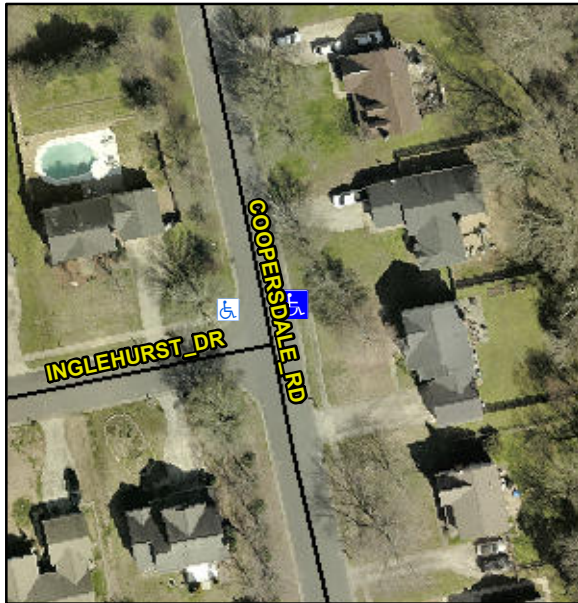
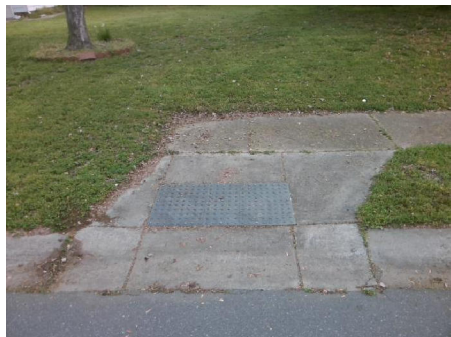
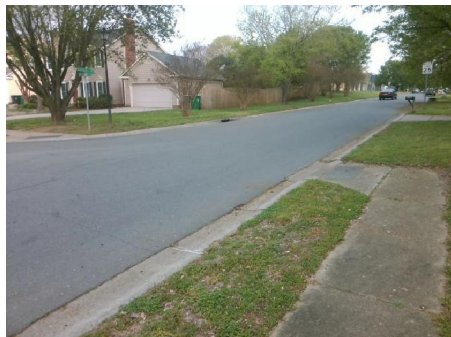
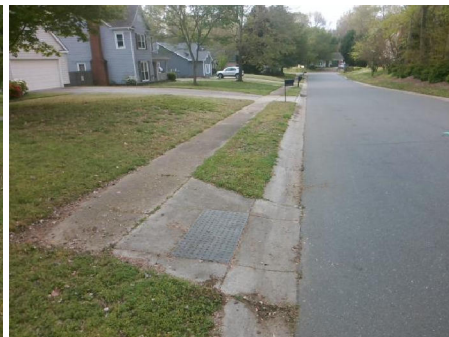
**Not Found, R304.2.2**

| Possible Solutions: | | | Compliance | Description | Data | Compliance | Description | Data |
|---|--|--|---|---|---|---|---|---|
| <b>Remove &amp; Replace Entire Ramp.</b> | | | N/A | Ramp Length (in) | 48.0 | No | Ramp Slope (%) | 8.9 |

### Remove & Replace Entire Ramp.
