# Access Compliance Report

## Public Rights-of-Way

### (Curb Ramps)

Intersection ID: 45179	Main Street: ELDON_DR	Cross Street: MAPLEHURST_DR	Location: NE
ADA ID: BAF7684021F2	Ramp Type: Perp	Initial Pass/Fail: Fail	Overall Compliance: No
Severity Score: 26.25			
Codes/Mitigation Info/Possible Solution		Field Measurements/Component Compliance

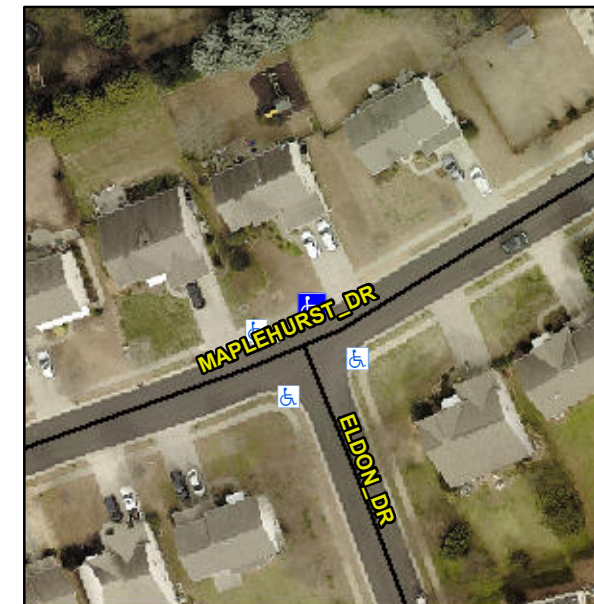
**Not Found, R304.2.2, R304.5.3**

Compliance	Description	Data	Compliance	Description	Data
N/A	Ramp Length (in)	47.0	No	Ramp Slope (%)	12.8
Yes	Ramp Width (in)	59.0	No	Ramp XSlope (%)	2.2
N/A	Flare Type LT	N/A	N/A	Flare Type RT	N/A
N/A	Flare Slope LT (%)	N/A	N/A	Flare Slope RT (%)	N/A
N/A	Flare Traversable LT?	N/A	N/A	Flare Traversable RT?	N/A
N/A	Landing Length (in)	N/A	N/A	DWS Provided?	N/A
N/A	Landing Width (in)	N/A	N/A	DWS Contrast?	N/A
N/A	Landing Slope (%)	N/A	N/A	DWS Length (in)	N/A
N/A	Landing X Slope (%)	N/A	N/A	DWS Full Width?	N/A
N/A	Landing Curb? (Y/N)	N/A	N/A	DWS Offset (in)	N/A
N/A	Shared Landing?	N/A			
N/A	Gutter Ponding?	N/A	N/A	Gutter Slope (%)	N/A
N/A	Gutter Lip Ht (in)	N/A	N/A	Gutter X Slope (%)	N/A
N/A	Painted X Walk1?	No	N/A	Painted X Walk2?	N/A
	X Walk 1 Direction	To SE		X Walk 2 Direction	N/A
N/A	X Walk 1 Width (in)	N/A	N/A	X Walk 2 Width (in)	N/A
	X Walk 1 Slope (%)	2.5		X Walk 2 Slope (%)	N/A
	X Walk 1 X Slope (%)	0.8		X Walk 2 X Slope (%)	N/A

N/A	Ramp inside XWalk1?	N/A	N/A	Ramp inside XWalk2?	N/A
	Road Slope (%)	N/A	N/A	Clear Space?	N/A
	Road X Slope (%)	N/A	N/A	Clear Space to XWalk (in)	N/A
N/A	Any Obstructions?	N/A	N/A	Storm Grate/Utility Hazard?	N/A
	Obstruction Type			Storm Grate/Utility Type	
		N/A			N/A
		Yes		Surface Condition? (G/P)	Good

**Remove & Replace Entire Ramp.**
