# Access Compliance Report

## Public Rights-of-Way

### (Curb Ramps)

Intersection ID: 50344	Main Street: KELBURN_LN	Cross Street: FENWAY_DR	Location: NW
ADA ID: BAFAB0364EC8	Ramp Type: Perp	Initial Pass/Fail: Fail	Overall Compliance: No
		Severity Score: 10

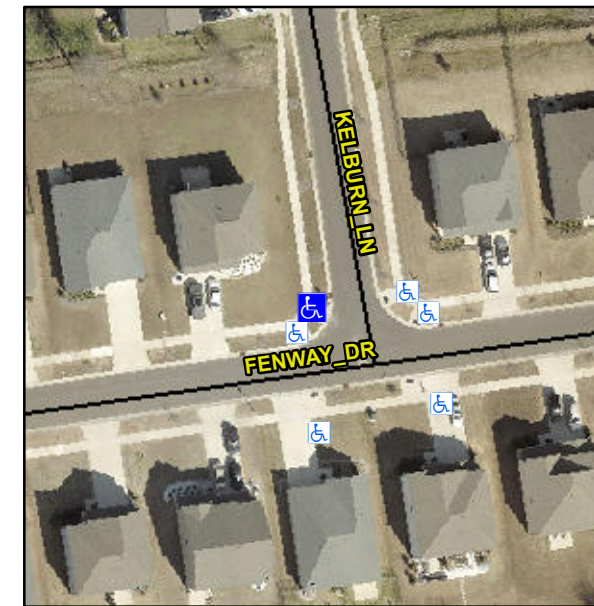
**Not Found, R304.5.1, R304.5.3**

Compliance	Description	Data	Compliance	Description	Data
N/A	Ramp Length (in)	100.0	Yes	Ramp Slope (%)	6.5
No	Ramp Width (in)	47.0	No	Ramp XSlope (%)	4.0
N/A	Flare Type LT	N/A	N/A	Flare Type RT	N/A
N/A	Flare Slope LT (%)	N/A	N/A	Flare Slope RT (%)	N/A
N/A	Flare Traversable LT?	N/A	N/A	Flare Traversable RT?	N/A
N/A	Landing Length (in)	N/A	N/A	DWS Provided?	N/A
N/A	Landing Width (in)	N/A	N/A	DWS Contrast?	N/A
N/A	Landing Slope (%)	N/A	N/A	DWS Length (in)	N/A
N/A	Landing X Slope (%)	N/A	N/A	DWS Full Width?	N/A
N/A	Landing Curb? (Y/N)	N/A	N/A	DWS Offset (in)	N/A
N/A	Shared Landing?	N/A			
N/A	Gutter Ponding?	N/A	N/A	Gutter Slope (%)	N/A
N/A	Gutter Lip Ht (in)	4.0	N/A	Gutter X Slope (%)	N/A
N/A	Painted X Walk1?	No	N/A	Painted X Walk2?	N/A
	X Walk 1 Direction	To E		X Walk 2 Direction	N/A
N/A	X Walk 1 Width (in)	N/A	N/A	X Walk 2 Width (in)	N/A
	X Walk 1 Slope (%)	3.1		X Walk 2 Slope (%)	N/A
	X Walk 1 X Slope (%)	3.8		X Walk 2 X Slope (%)	N/A

N/A	Ramp inside XWalk1?	N/A	N/A	Ramp inside XWalk2?	N/A
	Road Slope (%)	N/A	N/A	Clear Space?	N/A
	Road X Slope (%)	N/A	N/A	Clear Space to XWalk (in)	N/A
N/A	Any Obstructions?	N/A	N/A	Storm Grate/Utility Hazard?	N/A
	Obstruction Type			Storm Grate/Utility Type	
		N/A			N/A
			Yes	Surface Condition? (G/P)	Good

**Remove & Replace Entire Ramp.**
