Access Compliance Report Public Rights-of-Way (Curb Ramps)

Intersection ID: 9848 Main Street: THE_PLAZA Cross Street: LAKEDELL_DR Location: SE

ADA ID: BAFC9F71A11E Ramp Type: Perp Initial Pass/Fail: Fail Overall Compliance: No Severity Score: 22.5

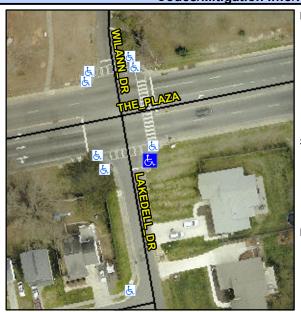
Field Measurements/Component Compliance							
Comp	liance Description	Data	Comp	liance Description	Data		
N/A	Ramp Length (in)	59.5	No	Ramp Slope (%)	9.0		
No	Ramp Width (in)	47.5	No	Ramp XSlope (%)	3.7		
N/A	Flare Type LT	N/A	N/A	Flare Type RT	N/A		
N/A	Flare Slope LT (%)	N/A	N/A	Flare Slope RT (%)	N/A		
N/A	Flare Traversable LT?	N/A	N/A	Flare Traversable RT?	N/A		
N/A	Landing Length (in)	N/A	N/A	DWS Provided?	N/A		
N/A	Landing Width (in)	N/A	N/A	DWS Contrast?	N/A		
N/A	Landing Slope (%)	N/A	N/A	DWS Length (in)	N/A		
N/A	Landing X Slope (%)	N/A	N/A	DWS Full Width?	N/A		
N/A	Landing Curb? (Y/N)	N/A	N/A	DWS Offset (in)	N/A		
N/A	Shared Landing?	N/A					
N/A	Gutter Ponding?	N/A	N/A	Gutter Slope (%)	N/A		
N/A	Gutter Lip Ht (in)	N/A	N/A	Gutter X Slope (%)	N/A		
N/A	Painted X Walk1?	No	N/A	Painted X Walk2?	N/A		
	X Walk 1 Direction	To W		X Walk 2 Direction	N/A		
N/A	X Walk 1 Width (in)	N/A	N/A	X Walk 2 Width (in)	N/A

X Walk 1 Slope (%)	1.0		X Walk 2 Slope (%)	N/A		
	X Walk 1 X Slope (%)	2.0		X Walk 2 X Slope (%)	N/A		
N/A	Ramp inside XWalk1?	N/A	N/A	Ramp inside XWalk2?	N/A		
	Road Slope (%)	N/A	N/A	Clear Space?	N/A		
	Road X Slope (%)	N/A	N/A	Clear Space to XWalk (in)	N/A		
N/A	Any Obstructions?	N/A	N/A	Storm Grate/Utility Hazard?	N/A		
	Obstruction Type			Storm Grate/Utility Type			
		N/A			N/A		
			Yes	Surface Condition? (G/P)	Good

Possible Solutions:					
Remove & Replace Entire Ramp.					
·					
Surveyor Notes:					
N/A					
DDOW/ADA					
PROW/ADA:					
Not Found, R304.5.1, R304.2.2, R304.5.3					
•
