Access Compliance Report Public Rights-of-Way (Curb Ramps)

Intersection ID: 13985 Main Street: CAMDEN_RD Cross Street: EAST_BV Location: NW

ADA ID: BB03E2E6A45C Ramp Type: Directional1 Initial Pass/Fail: Fail Overall Compliance: No Severity Score: 13.75

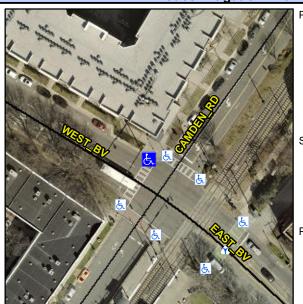
Field Measurements/Component Compilance						
	Compliance Description		Data	Compliance Description		Data
	N/A	Ramp Length (in)	62.0	N/A	Grade Break?	N/A
	Yes	Ramp Width (in)	78.0	N/A	Grade Break Slope (%)	0.0
	No	Ramp Slope (%)	8.4	N/A	Grade Break XSlope (%)	0.0
	Yes	Ramp XSlope (%)	2.8			
	N/A	Flare Type LT	N/A	N/A	Flare Type RT	N/A
	N/A	Flare Slope LT (%)	N/A	N/A	Flare Slope RT (%)	0.0
	N/A	Flare Traversable LT?	N/A	N/A	Flare Traversable RT?	N/A
	N/A	Landing Length (in)	0.0	N/A	DWS Provided?	N/A
	N/A	Landing Width (in)	0.0	N/A	DWS Contrast?	N/A
	N/A	Landing Slope (%)	0.0	N/A	DWS Length (in)	N/A
	N/A	Landing X Slope (%)	0.0	N/A	DWS Full Width?	N/A
	N/A	Landing Curb? (Y/N)	N/A	N/A	DWS Offset LT (in)	N/A
	N/A	Shared Landing?	N/A	N/A	DWS Offset RT (in)	N/A
	N/A	Gutter Ponding?	0.0	N/A	Gutter Slope (%)	N/A
	N/A	Gutter Lip Ht (in)	0.0	N/A	Gutter X Slope (%)	N/A
	N/A	Painted X Walk1?	Yes		Road Slope (%)	3.8
		X Walk 1 Direction	To SW		Road X Slope (%)	4.6

X Walk 1 Width (in)	99.0		Clear Space?	N/A
		X Walk 1 Slope (%)	3.8	N/A	Clear Space to XWalk (in)	N/A
		X Walk 1 X Slope (%)	4.6	N/A	Storm Grate/Utility Hazard?	N/A
	N/A	Ramp inside XWalk1?	Yes		Storm Grate/Utility Type	
	N/A	Any Obstructions?	N/A			N/A
		Obstruction Type		Yes	Surface Condition? (G/P)	Good
			N/A	N/A	Curb Slope (%)	13.4

Remove & Replace Entire Ramp.
