Access Compliance Report

Public Rights-of-Way

(Curb Ramps)

Intersection ID: N/A	Main Street: MORABLIN_DR	Cross Street: CARAGANA_CT	Location: S
ADA ID: BB0C3A79CEEC	Ramp Type: PerpDiag	Initial Pass/Fail: Fail	Overall Compliance: No
Severity Score: 35			
Codes/Mitigation Info/Possible Solution		Field Measurements/Component Compliance

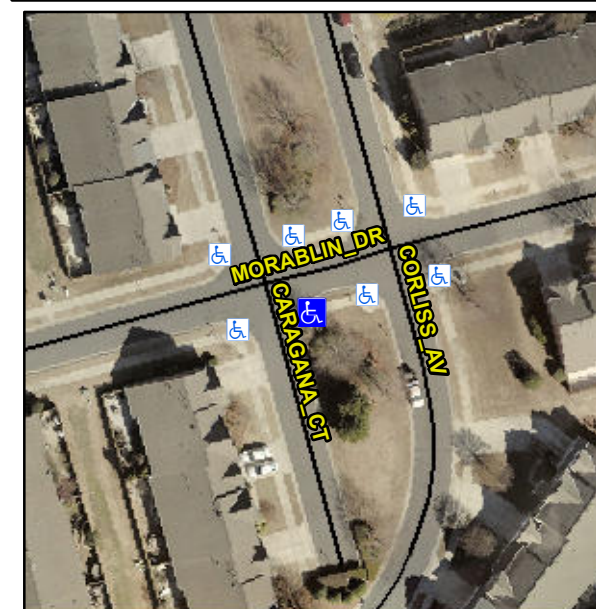
Not Found, R304.5.1

Compliance	Description	Data	Compliance	Description	Data
N/A	Ramp Length (in)	89.0	Yes	Ramp Slope (%)	5.2
No	Ramp Width (in)	30.0	Yes	Ramp XSlope (%)	1.8
N/A	Flare Type LT	N/A	N/A	Flare Type RT	N/A
N/A	Flare Slope LT (%)	N/A	N/A	Flare Slope RT (%)	N/A
N/A	Flare Traversable LT?	N/A	N/A	Flare Traversable RT?	N/A
N/A	Landing Length (in)	N/A	N/A	DWS Provided?	N/A
N/A	Landing Width (in)	N/A	N/A	DWS Contrast?	N/A
N/A	Landing Slope (%)	N/A	N/A	DWS Length (in)	N/A
N/A	Landing X Slope (%)	N/A	N/A	DWS Full Width?	N/A
N/A	Landing Curb? (Y/N)	N/A	N/A	DWS Offset (in)	N/A
N/A	Shared Landing?	N/A			
N/A	Gutter Ponding?	N/A	N/A	Gutter Slope (%)	N/A
N/A	Gutter Lip Ht (in)	N/A	N/A	Gutter X Slope (%)	N/A
N/A	Painted X Walk1?	No	N/A	Painted X Walk2?	No
	X Walk 1 Direction	To N		X Walk 2 Direction	To W
N/A	X Walk 1 Width (in)	N/A	N/A	X Walk 2 Width (in)	N/A
	X Walk 1 Slope (%)	2.4		X Walk 2 Slope (%)	4.1
	X Walk 1 X Slope (%)	3.7		X Walk 2 X Slope (%)	5.1

N/A	Ramp inside XWalk1?	N/A	N/A	Ramp inside XWalk2?	N/A
	Road Slope (%)	0.3	N/A	Clear Space?	N/A
	Road X Slope (%)	4.7	N/A	Clear Space to XWalk (in)	N/A
N/A	Any Obstructions?	N/A	N/A	Storm Grate/Utility Hazard?	N/A
	Obstruction Type			Storm Grate/Utility Type	
		N/A			N/A
			Yes	Surface Condition? (G/P)	Good

Remove & Replace Curb Ramp With Two New Directional Ramps or Equivalent.
