# Access Compliance Report

## Public Rights-of-Way

Intersection ID: 13450	Main Street: S_MCDOWELL_ST	Cross Street: E_MARTIN_LUTHER_KING_JR_BV	Location: N
ADA ID: BB263007802B	Ramp Type: PerpDiag	Initial Pass/Fail: Fail	Overall Compliance: No
		Severity Score: 10

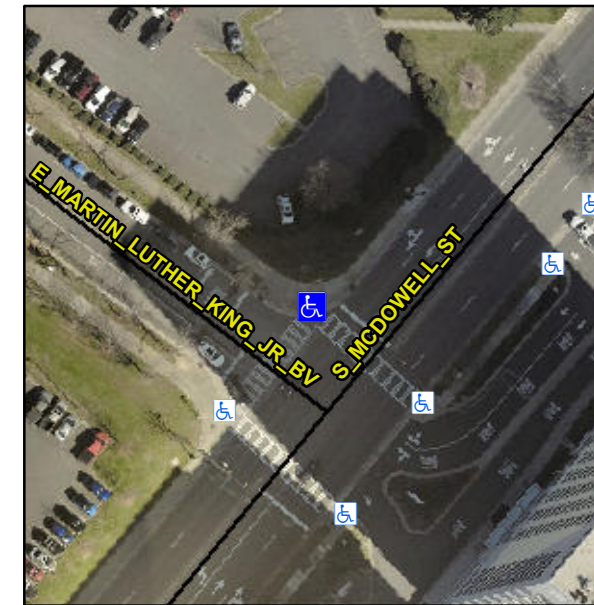
**Not Found, R304.5.1, R304.5.3**

Compliance	Description	Data	Compliance	Description	Data
N/A	Ramp Length (in)	88.0	Yes	Ramp Slope (%)	6.3
No	Ramp Width (in)	36.0	No	Ramp XSlope (%)	2.4
N/A	Flare Type LT	N/A	N/A	Flare Type RT	N/A
N/A	Flare Slope LT (%)	N/A	N/A	Flare Slope RT (%)	N/A
N/A	Flare Traversable LT?	N/A	N/A	Flare Traversable RT?	N/A
N/A	Landing Length (in)	N/A	N/A	DWS Provided?	N/A
N/A	Landing Width (in)	N/A	N/A	DWS Contrast?	N/A
N/A	Landing Slope (%)	N/A	N/A	DWS Length (in)	N/A
N/A	Landing X Slope (%)	N/A	N/A	DWS Full Width?	N/A
N/A	Landing Curb? (Y/N)	N/A	N/A	DWS Offset (in)	N/A
N/A	Shared Landing?	N/A			
N/A	Gutter Ponding?	N/A	N/A	Gutter Slope (%)	N/A
N/A	Gutter Lip Ht (in)	N/A	N/A	Gutter X Slope (%)	N/A
N/A	Painted X Walk1?	Yes	N/A	Painted X Walk2?	Yes
	X Walk 1 Direction	To SW		X Walk 2 Direction	To SE
N/A	X Walk 1 Width (in)	118.0	N/A	X Walk 2 Width (in)	112.0
	X Walk 1 Slope (%)	0.8		X Walk 2 Slope (%)	0.2
	X Walk 1 X Slope (%)	1.0		X Walk 2 X Slope (%)	2.0

N/A	Ramp inside XWalk1?	Yes	N/A	Ramp inside XWalk2?	Yes
	Road Slope (%)	1.6	N/A	Clear Space?	N/A
	Road X Slope (%)	1.1	N/A	Clear Space to XWalk (in)	N/A
N/A	Any Obstructions?	N/A	N/A	Storm Grate/Utility Hazard?	N/A
	Obstruction Type			Storm Grate/Utility Type	
		N/A			N/A
		Yes		Surface Condition? (G/P)	Good

**Remove & Replace Curb Ramp With Two New Directional Ramps or Equivalent.**

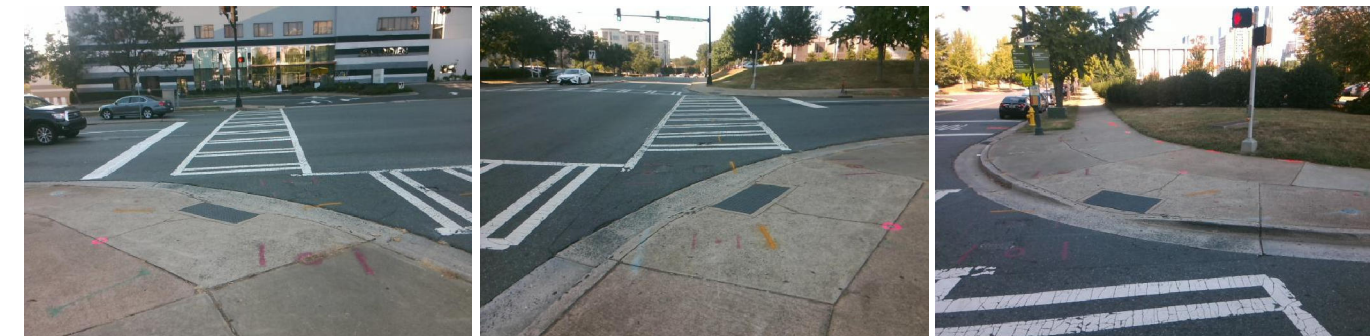
Street 1 Name **E MARTIN LUTHER KING JR BV**  
 Stop Condition-Street 2 **Signal**  
 Street 2 Name **S MCDOWELL ST**  
 Stop Condition-Street 1 **Signal**
