Access Compliance Report

Public Rights-of-Way

(Curb Ramps)

Intersection ID: 10034489	Main Street: PINEBURR_RD	Cross Street: N/A	Location: SE
ADA ID: BB34EC567F6B	Ramp Type: BlendTrans2	Initial Pass/Fail: Pass	Overall Compliance: No
			Severity Score: 10.25

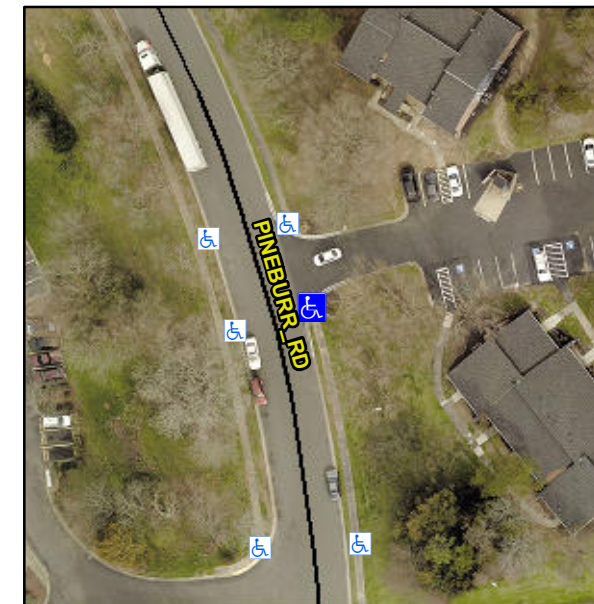
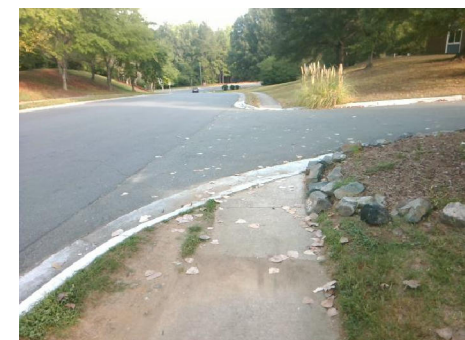
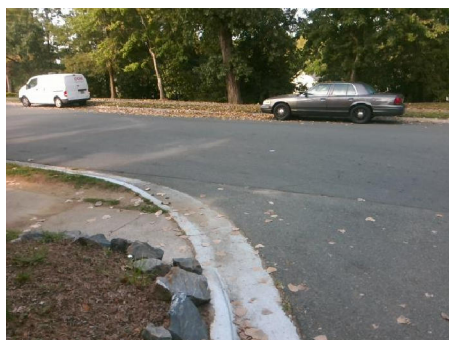
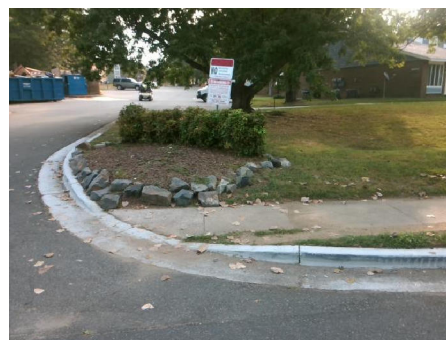
Not Found, R304.5.3, R305

Compliance	Description	Data	Compliance	Description	Data
N/A	Ramp Length (in)	40.0	Yes	BlendTrans Slope (%)	3.4
Yes	Ramp Width (in)	48.0	No	BlendTrans XSlope (%)	4.0
N/A	Flare Type LT	None	N/A	Flare Type RT	None
N/A	Flare Slope LT (%)	N/A	N/A	Flare Slope RT (%)	N/A
N/A	Flare Traversable LT?	N/A	N/A	Flare Traversable RT?	N/A
N/A	Landing Length (in)	N/A	No	DWS Provided?	No
N/A	Landing Width (in)	N/A	N/A	DWS Contrast?	No
N/A	Landing Slope (%)	N/A	N/A	DWS Length (in)	N/A
N/A	Landing X Slope (%)	N/A	N/A	DWS Full Width?	No
N/A	Landing Curb? (Y/N)	No	N/A	DWS Offset (in)	N/A
N/A	Shared Landing?	No			
Yes	Gutter Ponding?	No	Yes	Gutter Slope (%)	0.8
Yes	Gutter Lip Ht (in)	0.0	Yes	Gutter X Slope (%)	1.9
N/A	Painted X Walk1?	No	N/A	Painted X Walk2?	No
	X Walk 1 Direction	To N		X Walk 2 Direction	To W
	X Walk 1 Width (in)	N/A		X Walk 2 Width (in)	N/A
	X Walk 1 Slope (%)	1.5		X Walk 2 Slope (%)	1.3
	X Walk 1 X Slope (%)	5.5		X Walk 2 X Slope (%)	1.3

N/A	Ramp inside XWalk1?	N/A	N/A	Ramp inside XWalk2?	N/A
	Road Slope (%)	2.9		Clear Space?	Yes
	Road X Slope (%)	3.5	N/A	Clear Space to XWalk (in)	N/A
Yes	Any Obstructions?	No	Yes	Storm Grate/Utility Hazard?	No
	Obstruction Type			Storm Grate/Utility Type	
		N/A			N/A
			Yes	Surface Condition? (G/P)	Good
			No	Curb Slope (%)	10.2

Remove & Replace Curb Ramp With Two New Directional Ramps or Equivalent.

Total Cost: \$ 3200.00
