# Access Compliance Report

## Public Rights-of-Way

### (Curb Ramps)

| Intersection ID: 13679 | Main Street: EUCLID_AV | Cross Street: LEXINGTON_AV | Location: E |

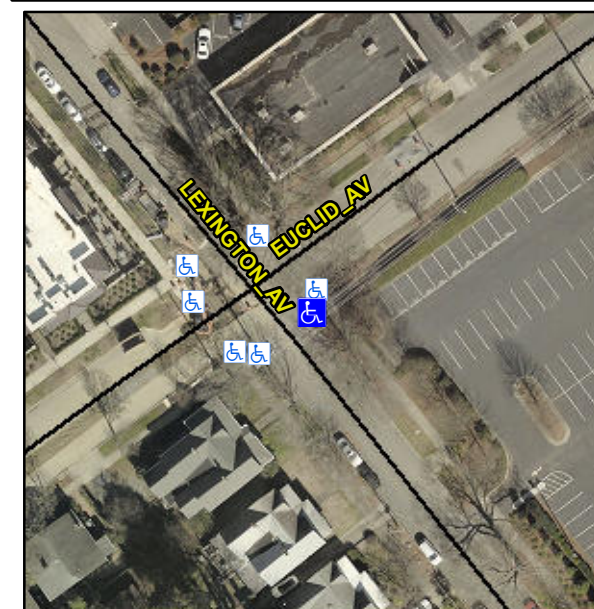
| ADA ID: BB525C45DE8D | Ramp Type: Directional1 | Initial Pass/Fail: Fail | Overall Compliance: No |

**R304.2.2, R304.5.3**

| Compliance | Description | Data | Compliance | Description | Data |
|---|---|---|---|---|---|
| No | Ramp Slope (%) | 16.7 | N/A | Grade Break XSlope (%) | 0.0 |
| No | Ramp XSlope (%) | 2.6 | | | |

**Remove & Replace Entire Ramp.**

Total Cost: \$ 1600.00
