# Access Compliance Report

## Public Rights-of-Way

### (Curb Ramps)

Intersection ID: 12830	Main Street: CARYA_POND_LN	Cross Street: HICKORY_GROVE_RD	Location: NE
ADA ID: BB549A2294E0	Ramp Type: Perp	Initial Pass/Fail: Pass	Overall Compliance: No
		Severity Score: 0

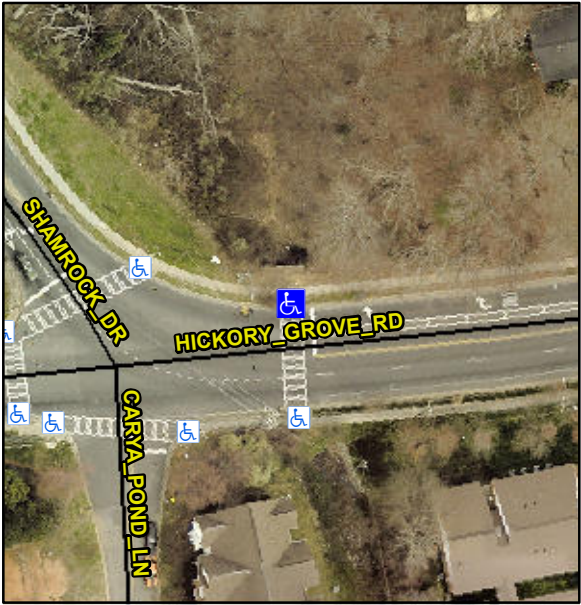
Possible Solutions:		<b>Compliance</b>	<b>Description</b>	<b>Data</b>
	<b>Remove &amp; Replace Entire Ramp.</b>		<b>Yes</b>	Ramp Length (in)	50.0
			<b>Yes</b>	Ramp Width (in)	49.0
			<b>N/A</b>	Flare Type LT	Sloped
			<b>N/A</b>	Flare Slope LT (%)	5.2
			<b>N/A</b>	Flare Traversable LT?	Yes
			<b>Yes</b>	Landing Length (in)	57.0
			<b>Yes</b>	Landing Width (in)	49.0
			<b>Yes</b>	Landing Slope (%)	1.3
			<b>Yes</b>	Landing X Slope (%)	0.7
<p>Surveyor Notes:</p> <p><b>N/A</b></p> <p>PROW/ADA:</p> <p><b>Not Found</b></p>			<b>N/A</b>	Flare Type RT	N/A
			<b>Yes</b>	Flare Slope RT (%)	5.4
			<b>N/A</b>	Flare Traversable RT?	Yes
			<b>Yes</b>	DWS Provided?	Yes
			<b>Yes</b>	DWS Contrast?	Yes
			<b>Yes</b>	DWS Length (in)	24.0
			<b>Yes</b>	DWS Full Width?	Yes
			<b>Yes</b>	DWS Offset (in)	0.5
			<b>No</b>	Shared Landing?	No

<b>No</b>	Gutter Ponding?	No
			<b>Yes</b>	Gutter Lip Ht (in)	0.0
			<b>N/A</b>	Painted X Walk1?	Yes
				X Walk 1 Direction	To S
			<b>N/A</b>	X Walk 1 Width (in)	120.0
				X Walk 1 Slope (%)	2.2
				X Walk 1 X Slope (%)	0.6
			<b>Yes</b>	Ramp inside XWalk1?	Yes
			<b>N/A</b>	Road Slope (%)	N/A
			<b>N/A</b>	Road X Slope (%)	N/A
			<b>Yes</b>	Any Obstructions?	No
				Obstruction Type	
			<b>N/A</b>		
			<b>Yes</b>	Surface Condition? (G/P)	Good
Total Cost:		\$ 1850.00
