Access Compliance Report

Public Rights-of-Way (Curb Ramps)

Intersection ID: 11838	Main Street: MECKLENBURG_AV	Cross Street: FORT_ST	Location: SW
ADA ID: BB5909BFDC05	Ramp Type: Directional1	Initial Pass/Fail: Fail	Overall Compliance: No
		Severity Score: 1.25

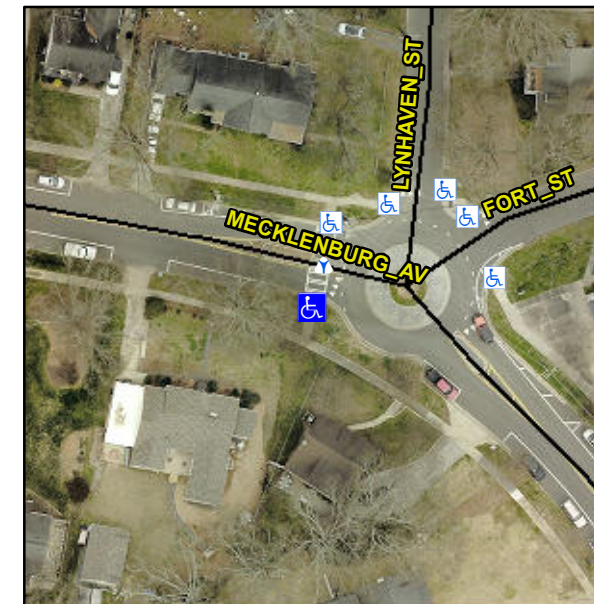
Compliance	Description	Data	Compliance	Description	Data
N/A	Ramp Length (in)	105.0	N/A	Grade Break?	N/A
Yes	Ramp Width (in)	58.0	N/A	Grade Break Slope (%)	0.0
Yes	Ramp Slope (%)	7.2	N/A	Grade Break XSlope (%)	0.0
No	Ramp XSlope (%)	2.3			
N/A	Flare Type LT	N/A	N/A	Flare Type RT	N/A
N/A	Flare Slope LT (%)	N/A	N/A	Flare Slope RT (%)	0.0
N/A	Flare Traversable LT?	N/A	N/A	Flare Traversable RT?	N/A
N/A	Landing Length (in)	0.0	N/A	DWS Provided?	N/A
N/A	Landing Width (in)	0.0	N/A	DWS Contrast?	N/A
N/A	Landing Slope (%)	0.0	N/A	DWS Length (in)	N/A
N/A	Landing X Slope (%)	0.0	N/A	DWS Full Width?	N/A
N/A	Landing Curb? (Y/N)	N/A	N/A	DWS Offset LT (in)	N/A
N/A	Shared Landing?	N/A	N/A	DWS Offset RT (in)	N/A
N/A	Gutter Ponding?	0.0	N/A	Gutter Slope (%)	N/A
N/A	Gutter Lip Ht (in)	0.0	N/A	Gutter X Slope (%)	N/A
N/A	Painted X Walk1?	Yes		Road Slope (%)	2.8
	X Walk 1 Direction	To N		Road X Slope (%)	3.4
	X Walk 1 Width (in)	114.0		Clear Space?	N/A

X Walk 1 Slope (%)	2.8	N/A	Clear Space to XWalk (in)	N/A
	X Walk 1 X Slope (%)	3.4	N/A	Storm Grate/Utility Hazard?	N/A
N/A	Ramp inside XWalk1?	Yes		Storm Grate/Utility Type	
N/A	Any Obstructions?	N/A			N/A
	Obstruction Type		Yes	Surface Condition? (G/P)	Good
			N/A	Curb Slope (%)	8.8

Possible Solutions:

Remove & Replace Entire Ramp.

PROW/ADA:

R304.5.3
