Access Compliance Report

Public Rights-of-Way

(Curb Ramps)

Intersection ID: 11619	Main Street: E_15TH_ST	Cross Street: N_CALDWELL_ST	Location: S
ADA ID: BB6225F2F051	Ramp Type: PerpDiag	Initial Pass/Fail: Fail	Overall Compliance: No
		Severity Score: 35

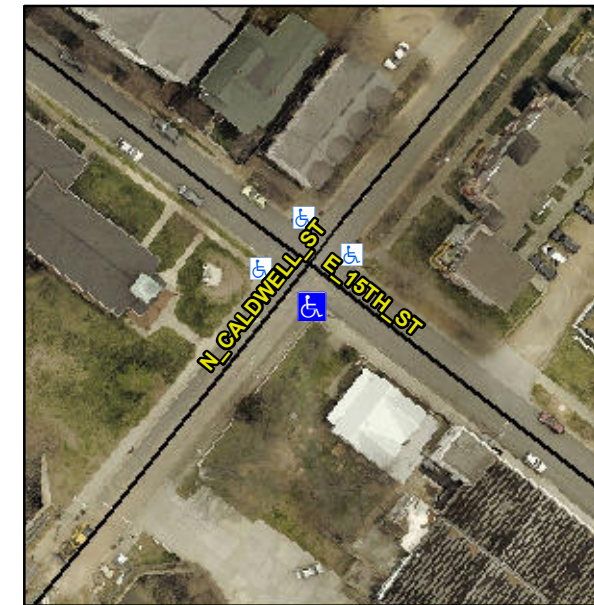
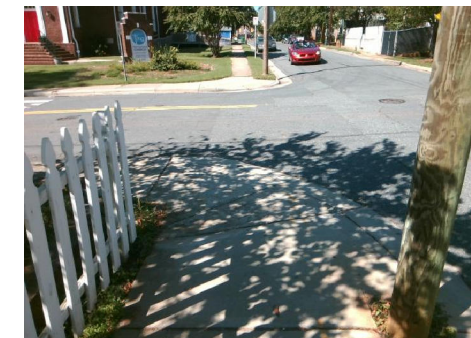
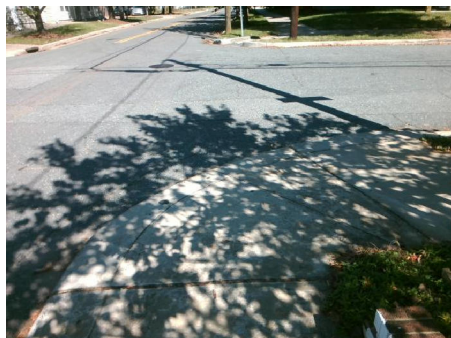
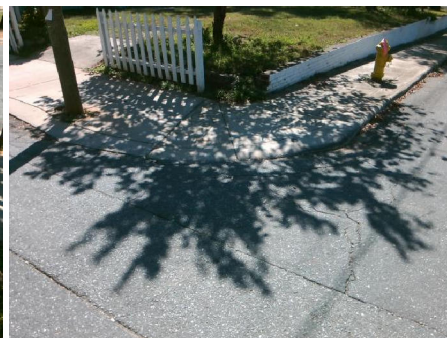
Not Found, R304.5.1

Compliance	Description	Data	Compliance	Description	Data
N/A	Ramp Length (in)	70.0	Yes	Ramp Slope (%)	6.9
No	Ramp Width (in)	24.0	Yes	Ramp XSlope (%)	1.3
N/A	Flare Type LT	N/A	N/A	Flare Type RT	N/A
N/A	Flare Slope LT (%)	N/A	N/A	Flare Slope RT (%)	N/A
N/A	Flare Traversable LT?	N/A	N/A	Flare Traversable RT?	N/A
N/A	Landing Length (in)	N/A	N/A	DWS Provided?	N/A
N/A	Landing Width (in)	N/A	N/A	DWS Contrast?	N/A
N/A	Landing Slope (%)	N/A	N/A	DWS Length (in)	N/A
N/A	Landing X Slope (%)	N/A	N/A	DWS Full Width?	N/A
N/A	Landing Curb? (Y/N)	N/A	N/A	DWS Offset (in)	N/A
N/A	Shared Landing?	N/A			
N/A	Gutter Ponding?	N/A	N/A	Gutter Slope (%)	N/A
N/A	Gutter Lip Ht (in)	0.5	N/A	Gutter X Slope (%)	N/A
N/A	Painted X Walk1?	No	N/A	Painted X Walk2?	No
	X Walk 1 Direction	To NE		X Walk 2 Direction	To NW
N/A	X Walk 1 Width (in)	N/A	N/A	X Walk 2 Width (in)	N/A
	X Walk 1 Slope (%)	10.2		X Walk 2 Slope (%)	5.2
	X Walk 1 X Slope (%)	1.2		X Walk 2 X Slope (%)	8.7

N/A	Ramp inside XWalk1?	N/A	N/A	Ramp inside XWalk2?	N/A
	Road Slope (%)	1.8	N/A	Clear Space?	N/A
	Road X Slope (%)	9.9	N/A	Clear Space to XWalk (in)	N/A
N/A	Any Obstructions?	N/A	N/A	Storm Grate/Utility Hazard?	N/A
	Obstruction Type			Storm Grate/Utility Type	
		N/A			N/A
			Yes	Surface Condition? (G/P)	Good

Remove & Replace Curb Ramp With Two New Directional Ramps or Equivalent.
