# Access Compliance Report

## Public Rights-of-Way

### (Curb Ramps)

Intersection ID: 22022	Main Street: HAMPTONRIDGE_DR	Cross Street: HEATHSTEAD_PL	Location: NW
ADA ID: BB64272031AD	Ramp Type: PerpDiag	Initial Pass/Fail: Fail	Overall Compliance: No
Codes/Mitigation Info/Possible Solution		Field Measurements/Component Compliance	
Severity Score: 13.75

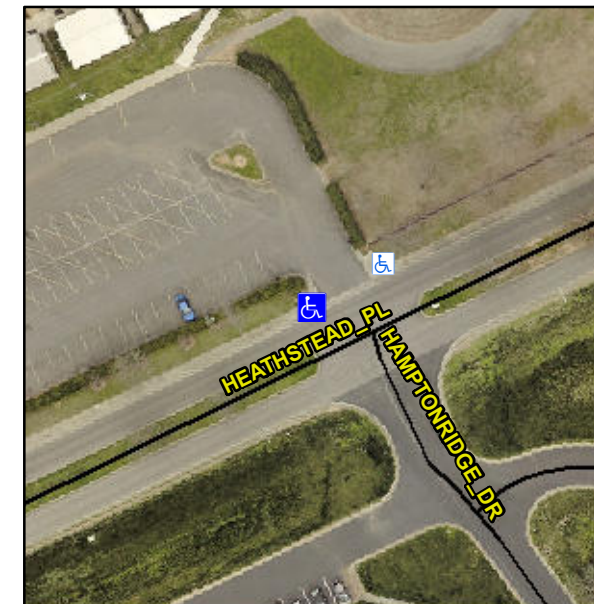
**Not Found, R304.2.2, R304.5.3**

Compliance	Description	Data	Compliance	Description	Data
N/A	Ramp Length (in)	60.0	No	Ramp Slope (%)	10.9
Yes	Ramp Width (in)	48.0	No	Ramp XSlope (%)	3.1
N/A	Flare Type LT	N/A	N/A	Flare Type RT	N/A
N/A	Flare Slope LT (%)	N/A	N/A	Flare Slope RT (%)	N/A
N/A	Flare Traversable LT?	N/A	N/A	Flare Traversable RT?	N/A
N/A	Landing Length (in)	N/A	N/A	DWS Provided?	N/A
N/A	Landing Width (in)	N/A	N/A	DWS Contrast?	N/A
N/A	Landing Slope (%)	N/A	N/A	DWS Length (in)	N/A
N/A	Landing X Slope (%)	N/A	N/A	DWS Full Width?	N/A
N/A	Landing Curb? (Y/N)	N/A	N/A	DWS Offset (in)	N/A
N/A	Shared Landing?	N/A			
N/A	Gutter Ponding?	N/A	N/A	Gutter Slope (%)	N/A
N/A	Gutter Lip Ht (in)	N/A	N/A	Gutter X Slope (%)	N/A
N/A	Painted X Walk1?	No	N/A	Painted X Walk2?	No
	X Walk 1 Direction	To SE		X Walk 2 Direction	To NE
N/A	X Walk 1 Width (in)	N/A	N/A	X Walk 2 Width (in)	N/A
	X Walk 1 Slope (%)	4.8		X Walk 2 Slope (%)	2.6
	X Walk 1 X Slope (%)	1.2		X Walk 2 X Slope (%)	3.9

N/A	Ramp inside XWalk1?	N/A	N/A	Ramp inside XWalk2?	N/A
	Road Slope (%)	3.4	N/A	Clear Space?	N/A
	Road X Slope (%)	4.4	N/A	Clear Space to XWalk (in)	N/A
N/A	Any Obstructions?	N/A	N/A	Storm Grate/Utility Hazard?	N/A
	Obstruction Type			Storm Grate/Utility Type	
		N/A			N/A
			Yes	Surface Condition? (G/P)	Good

**Remove & Replace Curb Ramp With Two New Directional Ramps or Equivalent.**
