Access Compliance Report

Public Rights-of-Way

(Curb Ramps)

Intersection ID: 8353	Main Street: LUCAS_LN	Cross Street: ORR_RD	Location: SE
ADA ID: BB7EB13F2B81	Ramp Type: PerpDiag	Initial Pass/Fail: Fail	Overall Compliance: No
Codes/Mitigation Info/Possible Solution		Field Measurements/Component Compliance	
Severity Score: 8.75

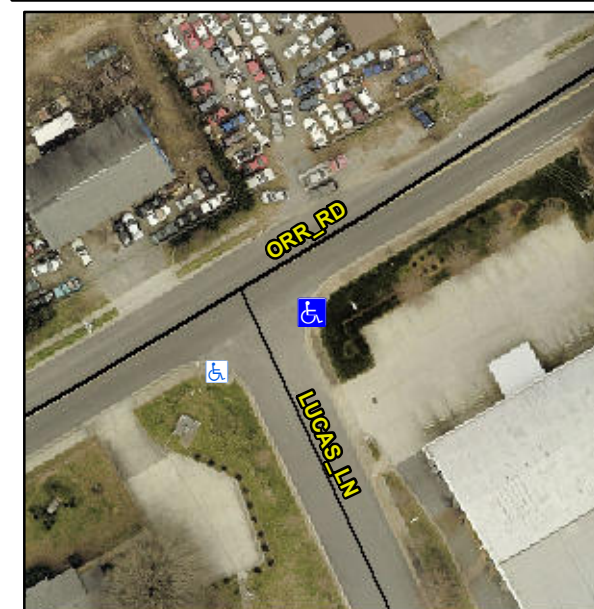
Not Found, R304.5.1

Compliance	Description	Data	Compliance	Description	Data
N/A	Ramp Length (in)	62.0	Yes	Ramp Slope (%)	8.1
No	Ramp Width (in)	42.0	Yes	Ramp XSlope (%)	1.8
N/A	Flare Type LT	N/A	N/A	Flare Type RT	N/A
N/A	Flare Slope LT (%)	N/A	N/A	Flare Slope RT (%)	N/A
N/A	Flare Traversable LT?	N/A	N/A	Flare Traversable RT?	N/A
N/A	Landing Length (in)	N/A	N/A	DWS Provided?	N/A
N/A	Landing Width (in)	N/A	N/A	DWS Contrast?	N/A
N/A	Landing Slope (%)	N/A	N/A	DWS Length (in)	N/A
N/A	Landing X Slope (%)	N/A	N/A	DWS Full Width?	N/A
N/A	Landing Curb? (Y/N)	N/A	N/A	DWS Offset (in)	N/A
N/A	Shared Landing?	N/A			
N/A	Gutter Ponding?	N/A	N/A	Gutter Slope (%)	N/A
N/A	Gutter Lip Ht (in)	1.0	N/A	Gutter X Slope (%)	N/A
N/A	Painted X Walk1?	No	N/A	Painted X Walk2?	No
	X Walk 1 Direction	To N		X Walk 2 Direction	To SW
N/A	X Walk 1 Width (in)	N/A	N/A	X Walk 2 Width (in)	N/A
	X Walk 1 Slope (%)	2.6		X Walk 2 Slope (%)	0.9
	X Walk 1 X Slope (%)	1.0		X Walk 2 X Slope (%)	1.0

N/A	Ramp inside XWalk1?	N/A	N/A	Ramp inside XWalk2?	N/A
	Road Slope (%)	0.9	N/A	Clear Space?	N/A
	Road X Slope (%)	0.2	N/A	Clear Space to XWalk (in)	N/A
N/A	Any Obstructions?	N/A	N/A	Storm Grate/Utility Hazard?	N/A
	Obstruction Type			Storm Grate/Utility Type	
		N/A			N/A
		Yes		Surface Condition? (G/P)	Good

Possible Solutions:

Remove & Replace Curb Ramp With Two New Directional Ramps or Equivalent.
