Access Compliance Report

Public Rights-of-Way

(Curb Ramps)

Intersection ID: N/A	Main Street: BLYTHNE_BV	Cross Street: N/A	Location: SE
ADA ID: BB819E86141A	Ramp Type: Perp	Initial Pass/Fail: Fail	Overall Compliance: No
Severity Score: 1.25			
Codes/Mitigation Info/Possible Solution		Field Measurements/Component Compliance

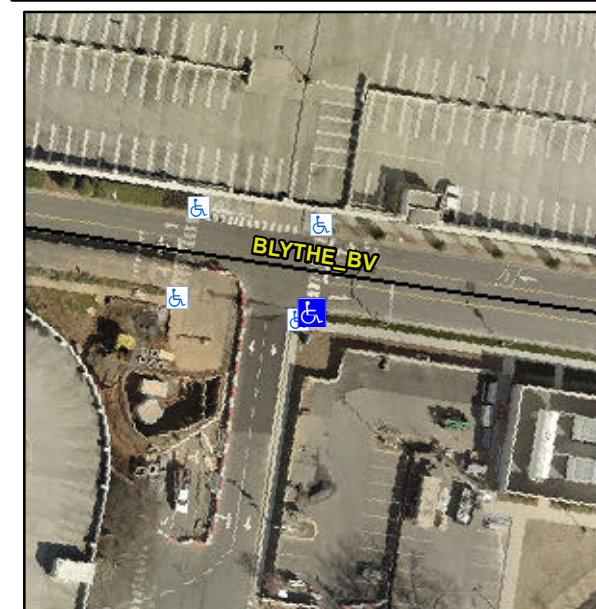
Not Found, R304.5.3

Compliance	Description	Data	Compliance	Description	Data
N/A	Ramp Length (in)	42.0	Yes	Ramp Slope (%)	5.5
Yes	Ramp Width (in)	48.0	No	Ramp XSlope (%)	2.8
N/A	Flare Type LT	N/A	N/A	Flare Type RT	N/A
N/A	Flare Slope LT (%)	N/A	N/A	Flare Slope RT (%)	N/A
N/A	Flare Traversable LT?	N/A	N/A	Flare Traversable RT?	N/A
N/A	Landing Length (in)	N/A	N/A	DWS Provided?	N/A
N/A	Landing Width (in)	N/A	N/A	DWS Contrast?	N/A
N/A	Landing Slope (%)	N/A	N/A	DWS Length (in)	N/A
N/A	Landing X Slope (%)	N/A	N/A	DWS Full Width?	N/A
N/A	Landing Curb? (Y/N)	N/A	N/A	DWS Offset (in)	N/A
N/A	Shared Landing?	N/A			
N/A	Gutter Ponding?	N/A	N/A	Gutter Slope (%)	N/A
N/A	Gutter Lip Ht (in)	N/A	N/A	Gutter X Slope (%)	N/A
N/A	Painted X Walk1?	Yes	N/A	Painted X Walk2?	N/A
	X Walk 1 Direction	To NE		X Walk 2 Direction	N/A
N/A	X Walk 1 Width (in)	74.0	N/A	X Walk 2 Width (in)	N/A
	X Walk 1 Slope (%)	3.6		X Walk 2 Slope (%)	N/A
	X Walk 1 X Slope (%)	0.8		X Walk 2 X Slope (%)	N/A

N/A	Ramp inside XWalk1?	Yes	N/A	Ramp inside XWalk2?	N/A
	Road Slope (%)	N/A	N/A	Clear Space?	N/A
	Road X Slope (%)	N/A	N/A	Clear Space to XWalk (in)	N/A
N/A	Any Obstructions?	N/A	N/A	Storm Grate/Utility Hazard?	N/A
	Obstruction Type			Storm Grate/Utility Type	
		N/A			N/A
			Yes	Surface Condition? (G/P)	Good

Remove & Replace Entire Ramp.

Total Cost: \$ 1850.00
