Access Compliance Report

Public Rights-of-Way

(Curb Ramps)

Intersection ID: N/A	Main Street: MINTVALE_DR	Cross Street: PALUSTRIS_CT	Location: N
ADA ID: BB96226E35EA	Ramp Type: Perp	Initial Pass/Fail: Fail	Overall Compliance: No
Codes/Mitigation Info/Possible Solution		Field Measurements/Component Compliance	
Severity Score: 31.25

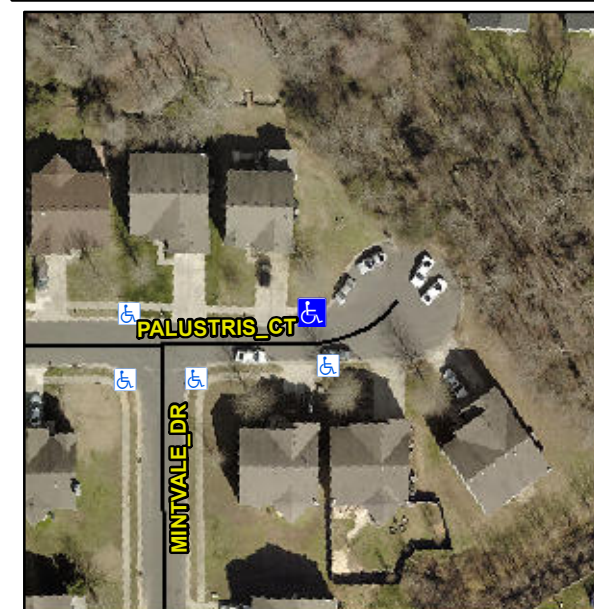
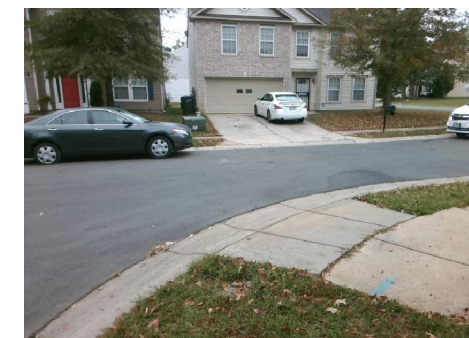
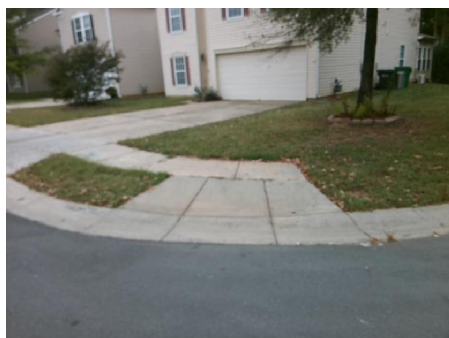
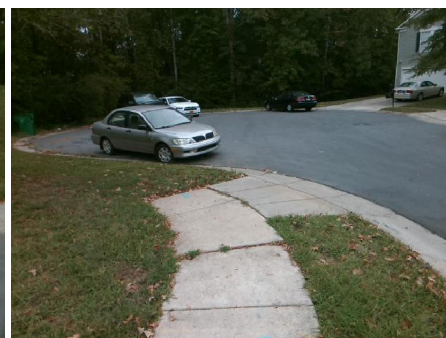
Not Found, R304.5.1, R304.2.2, R304.5.3

Compliance	Description	Data	Compliance	Description	Data
N/A	Ramp Length (in)	48.0	No	Ramp Slope (%)	9.1
No	Ramp Width (in)	33.0	No	Ramp XSlope (%)	4.6
N/A	Flare Type LT	N/A	N/A	Flare Type RT	N/A
N/A	Flare Slope LT (%)	N/A	N/A	Flare Slope RT (%)	N/A
N/A	Flare Traversable LT?	N/A	N/A	Flare Traversable RT?	N/A
N/A	Landing Length (in)	N/A	N/A	DWS Provided?	N/A
N/A	Landing Width (in)	N/A	N/A	DWS Contrast?	N/A
N/A	Landing Slope (%)	N/A	N/A	DWS Length (in)	N/A
N/A	Landing X Slope (%)	N/A	N/A	DWS Full Width?	N/A
N/A	Landing Curb? (Y/N)	N/A	N/A	DWS Offset (in)	N/A
N/A	Shared Landing?	N/A			
N/A	Gutter Ponding?	N/A	N/A	Gutter Slope (%)	N/A
N/A	Gutter Lip Ht (in)	N/A	N/A	Gutter X Slope (%)	N/A
N/A	Painted X Walk1?	No	N/A	Painted X Walk2?	N/A
	X Walk 1 Direction	To S		X Walk 2 Direction	N/A
N/A	X Walk 1 Width (in)	N/A	N/A	X Walk 2 Width (in)	N/A
	X Walk 1 Slope (%)	0.7		X Walk 2 Slope (%)	N/A
	X Walk 1 X Slope (%)	0.4		X Walk 2 X Slope (%)	N/A

Remove & Replace Entire Ramp.
