Access Compliance Report

Public Rights-of-Way

(Curb Ramps)

Intersection ID: 15270	Main Street: GRIFFITH_ST	Cross Street: NEW_BERN_ST	Location: SE
ADA ID: BBA50FF573B6	Ramp Type: Perp	Initial Pass/Fail: Fail	Overall Compliance: No
Severity Score: 13.75			
Codes/Mitigation Info/Possible Solution		Field Measurements/Component Compliance

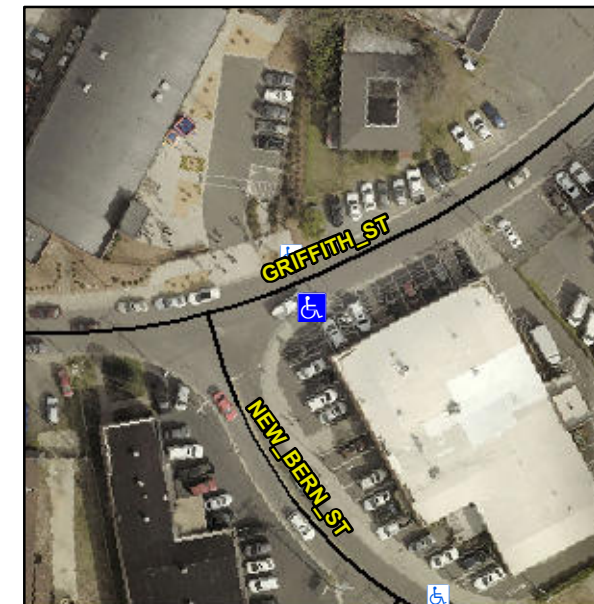
Not Found, R304.2.2, R304.5.3

Compliance	Description	Data	Compliance	Description	Data
N/A	Ramp Length (in)	70.0	No	Ramp Slope (%)	10.0
Yes	Ramp Width (in)	48.0	No	Ramp XSlope (%)	2.5
N/A	Flare Type LT	N/A	N/A	Flare Type RT	N/A
N/A	Flare Slope LT (%)	N/A	N/A	Flare Slope RT (%)	N/A
N/A	Flare Traversable LT?	N/A	N/A	Flare Traversable RT?	N/A
N/A	Landing Length (in)	N/A	N/A	DWS Provided?	N/A
N/A	Landing Width (in)	N/A	N/A	DWS Contrast?	N/A
N/A	Landing Slope (%)	N/A	N/A	DWS Length (in)	N/A
N/A	Landing X Slope (%)	N/A	N/A	DWS Full Width?	N/A
N/A	Landing Curb? (Y/N)	N/A	N/A	DWS Offset (in)	N/A
N/A	Shared Landing?	N/A			
N/A	Gutter Ponding?	N/A	N/A	Gutter Slope (%)	N/A
N/A	Gutter Lip Ht (in)	N/A	N/A	Gutter X Slope (%)	N/A
N/A	Painted X Walk1?	No	N/A	Painted X Walk2?	N/A
	X Walk 1 Direction	To NW		X Walk 2 Direction	N/A
N/A	X Walk 1 Width (in)	N/A	N/A	X Walk 2 Width (in)	N/A
	X Walk 1 Slope (%)	2.3		X Walk 2 Slope (%)	N/A
	X Walk 1 X Slope (%)	2.4		X Walk 2 X Slope (%)	N/A

N/A	Ramp inside XWalk1?	N/A	N/A	Ramp inside XWalk2?	N/A
	Road Slope (%)	N/A	N/A	Clear Space?	N/A
	Road X Slope (%)	N/A	N/A	Clear Space to XWalk (in)	N/A
N/A	Any Obstructions?	N/A	N/A	Storm Grate/Utility Hazard?	N/A
	Obstruction Type			Storm Grate/Utility Type	
		N/A			N/A
			Yes	Surface Condition? (G/P)	Good

Remove & Replace Entire Ramp.
