# Access Compliance Report

## Public Rights-of-Way

### (Curb Ramps)

Intersection ID: 28157	Main Street: LANDEN_DR	Cross Street: LONGMONT_DR	Location: NW
ADA ID: BBB506309FA3	Ramp Type: BlendTrans1	Initial Pass/Fail: Fail	Overall Compliance: No
			Severity Score: 21.25

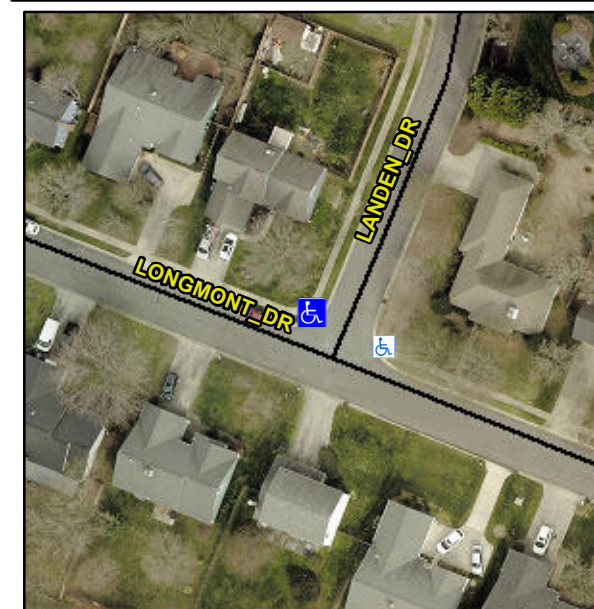
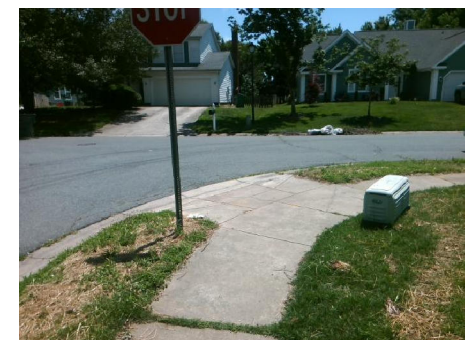
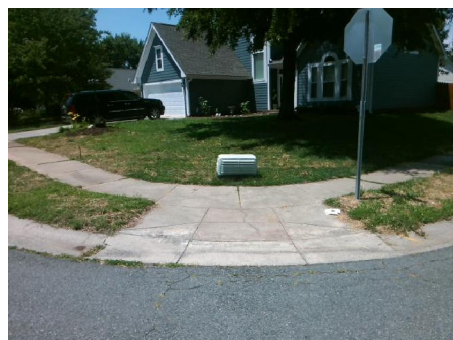
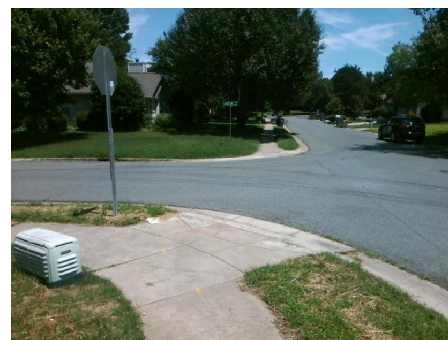
**Not Found, R304.5.1, R304.5.3**

Compliance	Description	Data	Compliance	Description	Data
N/A	Ramp Length (in)	46.5	Yes	BlendTrans Slope (%)	4.5
No	Ramp Width (in)	39.0	No	BlendTrans XSlope (%)	5.9
N/A	Flare Type LT	N/A	N/A	Flare Type RT	N/A
N/A	Flare Slope LT (%)	N/A	N/A	Flare Slope RT (%)	N/A
N/A	Flare Traversable LT?	N/A	N/A	Flare Traversable RT?	N/A
N/A	Landing Length (in)	N/A	N/A	DWS Provided?	N/A
N/A	Landing Width (in)	N/A	N/A	DWS Contrast?	N/A
N/A	Landing Slope (%)	N/A	N/A	DWS Length (in)	N/A
N/A	Landing X Slope (%)	N/A	N/A	DWS Full Width?	N/A
N/A	Landing Curb? (Y/N)	N/A	N/A	DWS Offset (in)	N/A
N/A	Shared Landing?	N/A			
N/A	Gutter Ponding?	N/A	N/A	Gutter Slope (%)	N/A
N/A	Gutter Lip Ht (in)	N/A	N/A	Gutter X Slope (%)	N/A
N/A	Painted X Walk1?	No	N/A	Painted X Walk2?	No
	X Walk 1 Direction	To S		X Walk 2 Direction	To SE
	X Walk 1 Width (in)	N/A		X Walk 2 Width (in)	N/A
	X Walk 1 Slope (%)	3.5		X Walk 2 Slope (%)	0.1
	X Walk 1 X Slope (%)	0.8		X Walk 2 X Slope (%)	2.9

N/A	Ramp inside XWalk1?	N/A	N/A	Ramp inside XWalk2?	N/A
	Road Slope (%)	2.6		Clear Space?	N/A
	Road X Slope (%)	3.5	N/A	Clear Space to XWalk (in)	N/A
N/A	Any Obstructions?	N/A	N/A	Storm Grate/Utility Hazard?	N/A
	Obstruction Type			Storm Grate/Utility Type	
		N/A			N/A
			Yes	Surface Condition? (G/P)	Good
			No	Curb Slope (%)	7.5

**Remove & Replace Curb Ramp With Two New Directional Ramps or Equivalent.**
