Access Compliance Report

Public Rights-of-Way

(Curb Ramps)

Intersection ID: 32275	Main Street: PRESCOTT_HILL_AV	Cross Street: SPRINGWELL_ST	Location: SW
ADA ID: BBB5463B432C	Ramp Type: Perp	Initial Pass/Fail: Fail	Overall Compliance: No
Severity Score: 12.5			
Codes/Mitigation Info/Possible Solution		Field Measurements/Component Compliance

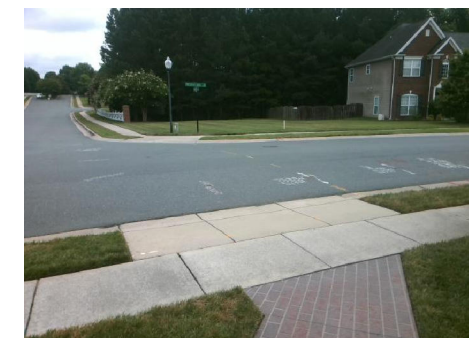
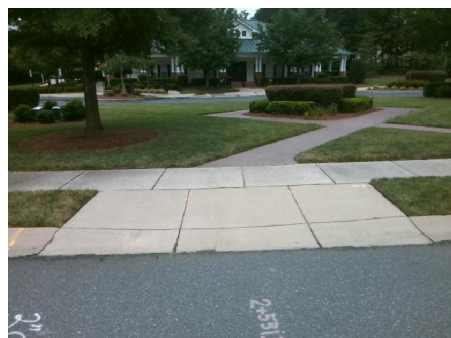
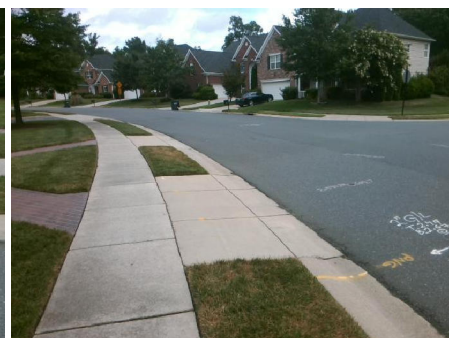
Compliance	Description	Data	Compliance	Description	Data
N/A	Ramp Length (in)	51.0	No	Ramp Slope (%)	10.5
Yes	Ramp Width (in)	63.0	Yes	Ramp XSlope (%)	0.6
N/A	Flare Type LT	N/A	N/A	Flare Type RT	N/A
N/A	Flare Slope LT (%)	N/A	N/A	Flare Slope RT (%)	N/A
N/A	Flare Traversable LT?	N/A	N/A	Flare Traversable RT?	N/A
N/A	Landing Length (in)	N/A	N/A	DWS Provided?	N/A
N/A	Landing Width (in)	N/A	N/A	DWS Contrast?	N/A
N/A	Landing Slope (%)	N/A	N/A	DWS Length (in)	N/A
N/A	Landing X Slope (%)	N/A	N/A	DWS Full Width?	N/A
N/A	Landing Curb? (Y/N)	N/A	N/A	DWS Offset (in)	N/A
N/A	Shared Landing?	N/A			
N/A	Gutter Ponding?	N/A	N/A	Gutter Slope (%)	N/A
N/A	Gutter Lip Ht (in)	N/A	N/A	Gutter X Slope (%)	N/A
N/A	Painted X Walk1?	No	N/A	Painted X Walk2?	N/A
	X Walk 1 Direction	To NE		X Walk 2 Direction	N/A
N/A	X Walk 1 Width (in)	N/A	N/A	X Walk 2 Width (in)	N/A
	X Walk 1 Slope (%)	5.4		X Walk 2 Slope (%)	N/A
	X Walk 1 X Slope (%)	0.2		X Walk 2 X Slope (%)	N/A

N/A	Ramp inside XWalk1?	N/A	N/A	Ramp inside XWalk2?	N/A
	Road Slope (%)	N/A	N/A	Clear Space?	N/A
	Road X Slope (%)	N/A	N/A	Clear Space to XWalk (in)	N/A
N/A	Any Obstructions?	N/A	N/A	Storm Grate/Utility Hazard?	N/A
	Obstruction Type			Storm Grate/Utility Type	
		N/A			N/A
			Yes	Surface Condition? (G/P)	Good

Remove & Replace Entire Ramp.
