# Access Compliance Report

## Public Rights-of-Way

### (Curb Ramps)

Intersection ID: 26458	Main Street: BRECHIN_DR	Cross Street: BROADFORD_CT	Location: NE
ADA ID: BBD682A0977F	Ramp Type: Perp	Initial Pass/Fail: Fail	Overall Compliance: No
Severity Score: 48.75			
Codes/Mitigation Info/Possible Solution		Field Measurements/Component Compliance

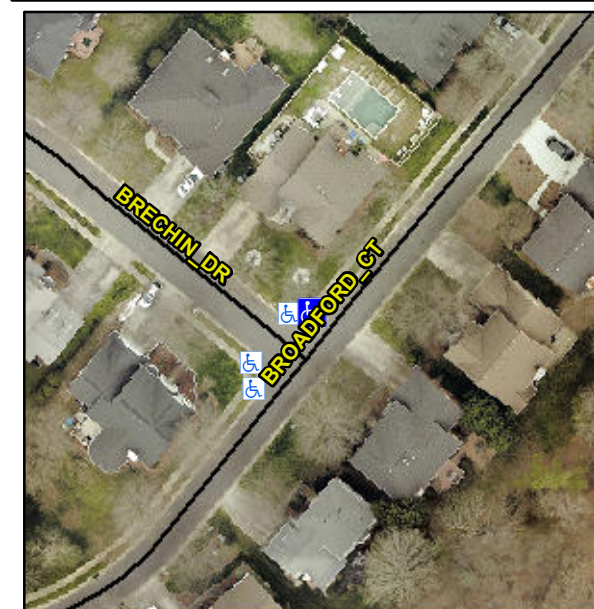
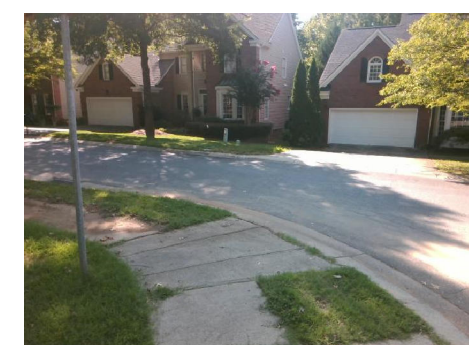
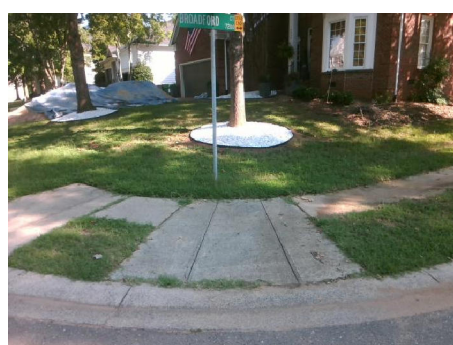
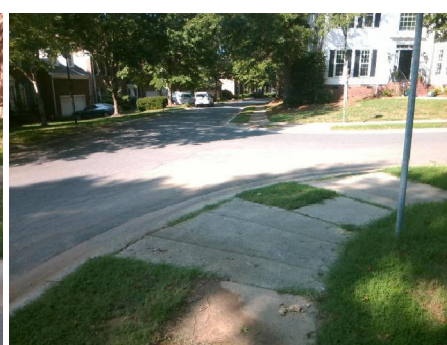
**R304.5.1, R304.2.2, R304.5.3**

Compliance	Description	Data	Compliance	Description	Data
N/A	Ramp Length (in)	94.0	No	Ramp Slope (%)	8.8
No	Ramp Width (in)	27.0	No	Ramp XSlope (%)	2.5
N/A	Flare Type LT	N/A	N/A	Flare Type RT	N/A
N/A	Flare Slope LT (%)	N/A	N/A	Flare Slope RT (%)	N/A
N/A	Flare Traversable LT?	N/A	N/A	Flare Traversable RT?	N/A
N/A	Landing Length (in)	N/A	N/A	DWS Provided?	N/A
N/A	Landing Width (in)	N/A	N/A	DWS Contrast?	N/A
N/A	Landing Slope (%)	N/A	N/A	DWS Length (in)	N/A
N/A	Landing X Slope (%)	N/A	N/A	DWS Full Width?	N/A
N/A	Landing Curb? (Y/N)	N/A	N/A	DWS Offset (in)	N/A
N/A	Shared Landing?	N/A			
N/A	Gutter Ponding?	N/A	N/A	Gutter Slope (%)	N/A
N/A	Gutter Lip Ht (in)	N/A	N/A	Gutter X Slope (%)	N/A
N/A	Painted X Walk1?	No	N/A	Painted X Walk2?	N/A
	X Walk 1 Direction	To SE		X Walk 2 Direction	N/A
N/A	X Walk 1 Width (in)	N/A	N/A	X Walk 2 Width (in)	N/A
	X Walk 1 Slope (%)	1.1		X Walk 2 Slope (%)	N/A
	X Walk 1 X Slope (%)	0.6		X Walk 2 X Slope (%)	N/A

N/A	Ramp inside XWalk1?	N/A	N/A	Ramp inside XWalk2?	N/A
	Road Slope (%)	N/A	N/A	Clear Space?	N/A
	Road X Slope (%)	N/A	N/A	Clear Space to XWalk (in)	N/A
N/A	Any Obstructions?	N/A	N/A	Storm Grate/Utility Hazard?	N/A
	Obstruction Type			Storm Grate/Utility Type	
		N/A			N/A
			Yes	Surface Condition? (G/P)	Good

**Remove & Replace Entire Ramp.**

Total Cost: \$ 1850.00
