# Access Compliance Report

## Public Rights-of-Way

### (Curb Ramps)

Intersection ID: N/A	Main Street: SMITH_RD	Cross Street: CANTERBURY_CASTLE_DR	Location: SW
ADA ID: BBDA30B8639A	Ramp Type: Perp	Initial Pass/Fail: Fail	Overall Compliance: No
Severity Score: 37.5			
Codes/Mitigation Info/Possible Solution		Field Measurements/Component Compliance

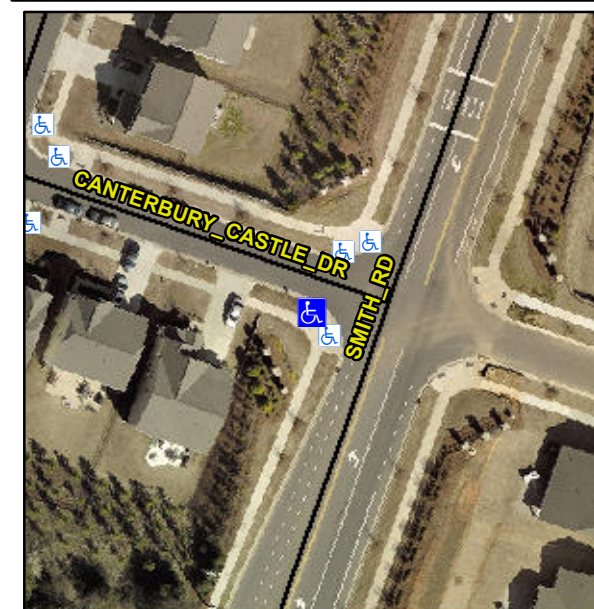
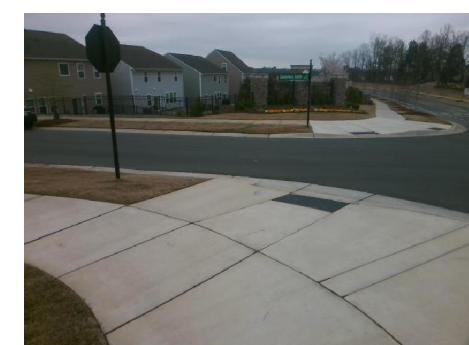
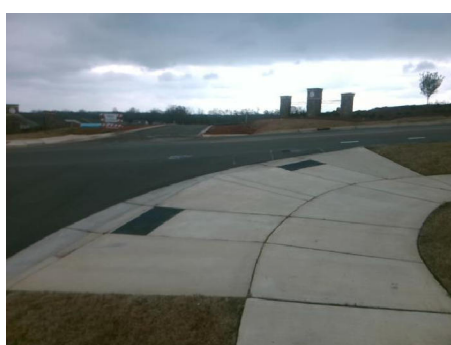
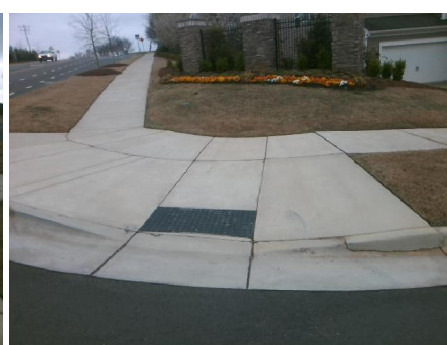
**Not Found, R304.2.2, R304.5.3**

Compliance	Description	Data	Compliance	Description	Data
N/A	Ramp Length (in)	96.0	No	Ramp Slope (%)	8.4
Yes	Ramp Width (in)	48.0	No	Ramp XSlope (%)	8.1
N/A	Flare Type LT	N/A	N/A	Flare Type RT	N/A
N/A	Flare Slope LT (%)	N/A	N/A	Flare Slope RT (%)	N/A
N/A	Flare Traversable LT?	N/A	N/A	Flare Traversable RT?	N/A
N/A	Landing Length (in)	N/A	N/A	DWS Provided?	N/A
N/A	Landing Width (in)	N/A	N/A	DWS Contrast?	N/A
N/A	Landing Slope (%)	N/A	N/A	DWS Length (in)	N/A
N/A	Landing X Slope (%)	N/A	N/A	DWS Full Width?	N/A
N/A	Landing Curb? (Y/N)	N/A	N/A	DWS Offset (in)	N/A
N/A	Shared Landing?	N/A			
N/A	Gutter Ponding?	N/A	N/A	Gutter Slope (%)	N/A
N/A	Gutter Lip Ht (in)	N/A	N/A	Gutter X Slope (%)	N/A
N/A	Painted X Walk1?	No	N/A	Painted X Walk2?	N/A
	X Walk 1 Direction	To NE		X Walk 2 Direction	N/A
N/A	X Walk 1 Width (in)	N/A	N/A	X Walk 2 Width (in)	N/A
	X Walk 1 Slope (%)	1.0		X Walk 2 Slope (%)	N/A
	X Walk 1 X Slope (%)	7.6		X Walk 2 X Slope (%)	N/A

N/A	Ramp inside XWalk1?	N/A	N/A	Ramp inside XWalk2?	N/A
	Road Slope (%)	N/A	N/A	Clear Space?	N/A
	Road X Slope (%)	N/A	N/A	Clear Space to XWalk (in)	N/A
N/A	Any Obstructions?	N/A	N/A	Storm Grate/Utility Hazard?	N/A
	Obstruction Type			Storm Grate/Utility Type	
		N/A			N/A
		Yes		Surface Condition? (G/P)	Good

**Remove & Replace Entire Ramp.**

Total Cost: \$ 1850.00
