Access Compliance Report Public Rights-of-Way (Curb Ramps)

· · · · · · · · · · · · · · · · · · ·									
Intersection ID: 45735 Main Street: REDWOOD_VALLEY_LN				Cross Street: COPPER LEAF_LN				Location:	NW
ADA ID: BBE439AB1B68 Ramp Type: PerpDiag			Initial P	nitial Pass/Fail: Fail Overall Compliance: No				o Severity Score:	10
Codes/Mitigation Info/Possible Solution				Field Measurements/Component Compliance					
		Possible Solutions:		Compliance Description			Data Compliance Description		Data
		Remove & Replace Curb Ramp V	Vith	N/A	Ramp Length (in)	49.0	Yes	Ramp Slope (%)	8.1
		Two New Directional Ramps or		No	Ramp Width (in)	46.0	No	Ramp XSlope (%)	2.9
		Equivalent.		N/A	Flare Type LT	N/A	N/A	Flare Type RT	N/A
	PLANK L			N/A	Flare Slope LT (%)	N/A	N/A	Flare Slope RT (%)	N/A
				N/A	Flare Traversable LT?	N/A	N/A	Flare Traversable RT?	N/A
1 1 1 1 1 1 1 1 1 1 1 1 1 1 1 1 1 1 1				N/A	Landing Length (in)	N/A	N/A	DWS Provided?	N/A
A TOPA AN	CONTRACTOR OF	Surveyor Notes:		N/A	Landing Width (in)	N/A	N/A	DWS Contrast?	N/A

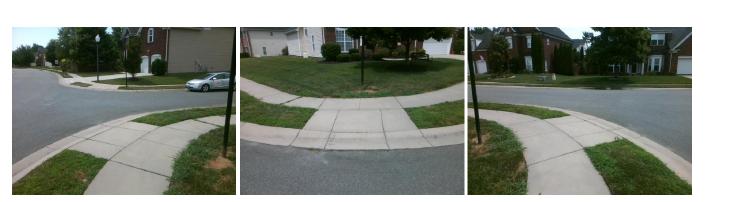
- Aller	N/A		N/A	Landing Slope (%)	N/A	N/A	DWS Length (in)	N/A
PROW/ADA: Not Found, R304.5.1, R304.5.3				N/A	Landing X Slope (%)	N/A	N/A	DWS Full Width?	N/A
				N/A	Landing Curb? (Y/N)	N/A	N/A	DWS Offset (in)	N/A
				N/A	Shared Landing?	N/A			
				N/A	Gutter Ponding?	N/A	N/A	Gutter Slope (%)	N/A
				N/A	Gutter Lip Ht (in)	1.8	N/A	Gutter X Slope (%)	N/A
				N/A	Painted X Walk1?	No	N/A	Painted X Walk2?	No
					X Walk 1 Direction	To SE		X Walk 2 Direction	To NE
				N/A	X Walk 1 Width (in)	N/A	N/A	X Walk 2 Width (in)	N/A
Street 1 Name	COPPER LEAF LN	-			X Walk 1 Slope (%)	2.0		X Walk 2 Slope (%)	2.8
Stop Condition-Street 2	StopSign				X Walk 1 X Slope (%)	2.3		X Walk 2 X Slope (%)	0.5
Street 2 Name	REDWOOD VALLEY LN			N/A	Ramp inside XWalk1?	N/A	N/A	Ramp inside XWalk2?	N/A
Stop Condition-Street 1	None				Road Slope (%)	1.9	N/A	Clear Space?	N/A
					Road X Slope (%)	2.1	N/A	Clear Space to XWalk (in)	N/A
				N/A	Any Obstructions?	N/A	N/A	Storm Grate/Utility Hazard?	N/A

Yes Surface Condition? (G/P)

Good

Total Cost: \$ 3	200.00		Obstruction Type			Storm Grate/Utility Type	
						N/A			N/A
