# Access Compliance Report

## Public Rights-of-Way

| Intersection ID: 48454 | Main Street: RED_RUST_LN | Cross Street: GOLF_LINKS_DR | Location: SW |
| ADA ID: BBE5858746C3 | Ramp Type: Perp | Initial Pass/Fail: Pass | Overall Compliance: No |

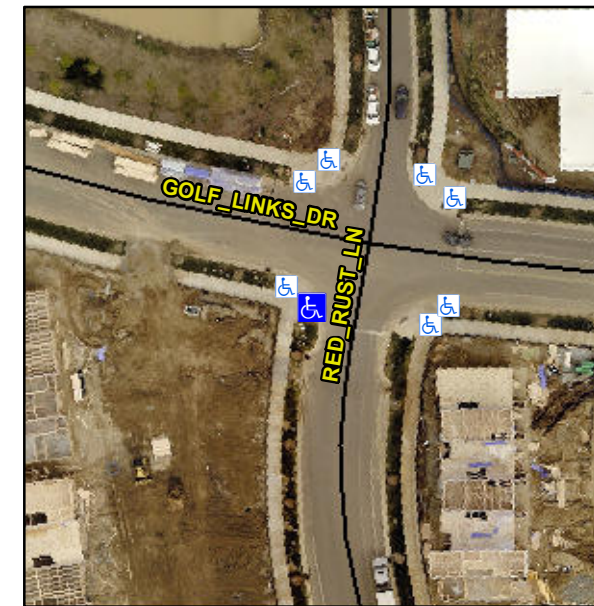
**Not Found, R304.5.3, R304.5.4**

| Compliance | Description | Data | Compliance | Description | Data |
|---|---|---|---|---|---|
| No | Landing X Slope (%) | 2.7 | Yes | DWS Full Width? | Yes |
| Yes | Gutter Ponding? | No | No | Gutter Slope (%) | 6.7 |

**Remove & Replace Entire Ramp.  
Remove & Replace Gutter.**

Total Cost: \$ 2600.00
