# Access Compliance Report

## Public Rights-of-Way

### (Curb Ramps)

Intersection ID: 28976	Main Street: BANNINGTON_RD	Cross Street: CARMEL_COMMONS_BV	Location: NW
ADA ID: BBED9B4FE816	Ramp Type: PerpDiag	Initial Pass/Fail: Fail	Overall Compliance: No
			Severity Score: 36.25

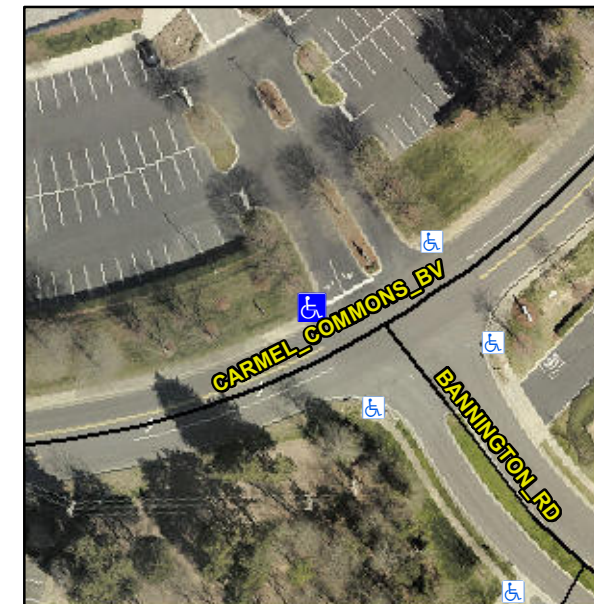
**Not Found, R304.5.1, R304.5.3**

Compliance	Description	Data	Compliance	Description	Data
N/A	Ramp Length (in)	61.0	Yes	Ramp Slope (%)	6.0
No	Ramp Width (in)	28.0	No	Ramp XSlope (%)	3.2
N/A	Flare Type LT	N/A	N/A	Flare Type RT	N/A
N/A	Flare Slope LT (%)	N/A	N/A	Flare Slope RT (%)	N/A
N/A	Flare Traversable LT?	N/A	N/A	Flare Traversable RT?	N/A
N/A	Landing Length (in)	N/A	N/A	DWS Provided?	N/A
N/A	Landing Width (in)	N/A	N/A	DWS Contrast?	N/A
N/A	Landing Slope (%)	N/A	N/A	DWS Length (in)	N/A
N/A	Landing X Slope (%)	N/A	N/A	DWS Full Width?	N/A
N/A	Landing Curb? (Y/N)	N/A	N/A	DWS Offset (in)	N/A
N/A	Shared Landing?	N/A			
N/A	Gutter Ponding?	N/A	N/A	Gutter Slope (%)	N/A
N/A	Gutter Lip Ht (in)	N/A	N/A	Gutter X Slope (%)	N/A
N/A	Painted X Walk1?	No	N/A	Painted X Walk2?	No
	X Walk 1 Direction	To S		X Walk 2 Direction	To E
N/A	X Walk 1 Width (in)	N/A	N/A	X Walk 2 Width (in)	N/A
	X Walk 1 Slope (%)	2.8		X Walk 2 Slope (%)	11.7
	X Walk 1 X Slope (%)	5.4		X Walk 2 X Slope (%)	7.5

N/A	Ramp inside XWalk1?	N/A	N/A	Ramp inside XWalk2?	N/A
	Road Slope (%)	1.1	N/A	Clear Space?	N/A
	Road X Slope (%)	9.2	N/A	Clear Space to XWalk (in)	N/A
N/A	Any Obstructions?	N/A	N/A	Storm Grate/Utility Hazard?	N/A
	Obstruction Type			Storm Grate/Utility Type	
		N/A			N/A
			Yes	Surface Condition? (G/P)	Good

**Remove & Replace Curb Ramp With Two New Directional Ramps or Equivalent.**

Total Cost: \$ 3200.00
