## **Access Compliance Report Public Rights-of-Way** (Curb Ramps)

Intersection ID: 53704 Main Street: MILLSTREAM RIDGE DR Cross Street: MILLSTREAM RIDGE DR Location: Ε **Severity Score:** 22.5 ADA ID: BBEE3A6822E7 Ramp Type: Combination1 Initial Pass/Fail: Fail **Overall Compliance: No**

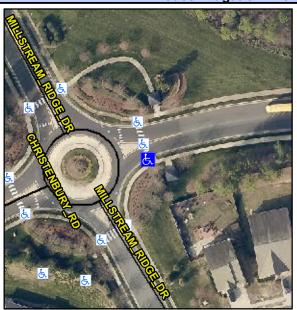
YieldSign Street 1 Name **CHRISTENBURY RD** Stop Condition-Street 1 N/A Street 2 Name Stop Condition-Street 2 N/A Possible Solutions: Compliance Description N/A Remove & Replace Entire Ramp. Yes Yes No N/A No Surveyor Notes: N/A **CURB GAP 1.5, LT RP < 5%** N/A N/A N/A N/A PROW/ADA: N/A R304.5.1, R304.5.3, R304.3.2 N/A N/A N/A N/A N/A N/A
