# Access Compliance Report

## Public Rights-of-Way

### (Curb Ramps)

Intersection ID: 14401	Main Street: BAXTER_ST	Cross Street: BALDWIN_AV	Location:	N
ADA ID: BBF33B27B14B	Ramp Type: PerpDiag	Initial Pass/Fail: Fail	Overall Compliance: No	Severity Score: 12.5

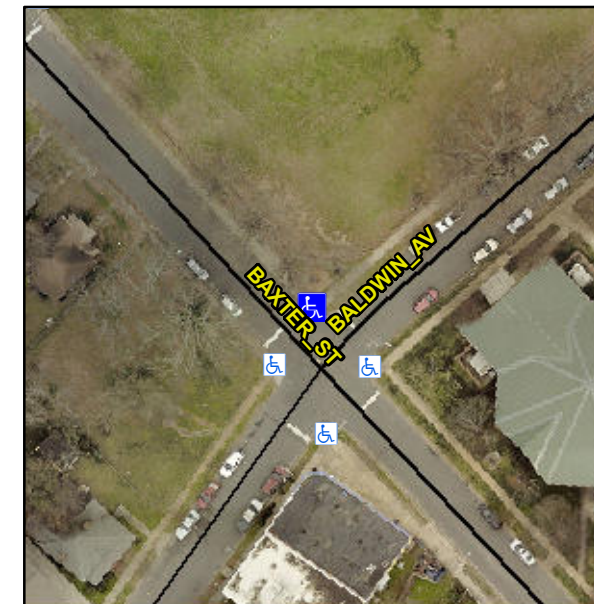
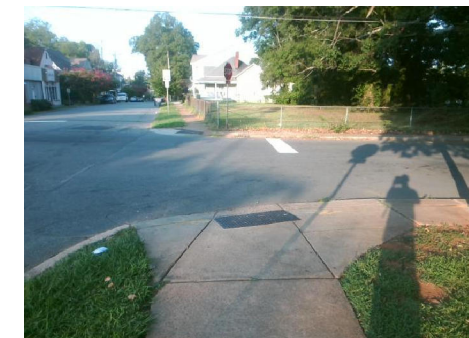
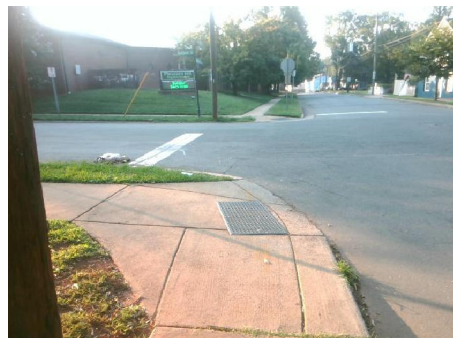
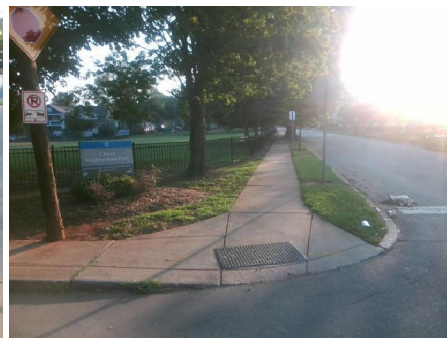
Compliance	Description	Data	Compliance	Description	Data
N/A	Ramp Length (in)	87.0	No	Ramp Slope (%)	10.7
Yes	Ramp Width (in)	48.0	Yes	Ramp XSlope (%)	1.9
N/A	Flare Type LT	N/A	N/A	Flare Type RT	N/A
N/A	Flare Slope LT (%)	N/A	N/A	Flare Slope RT (%)	N/A
N/A	Flare Traversable LT?	N/A	N/A	Flare Traversable RT?	N/A
N/A	Landing Length (in)	N/A	N/A	DWS Provided?	N/A
N/A	Landing Width (in)	N/A	N/A	DWS Contrast?	N/A
N/A	Landing Slope (%)	N/A	N/A	DWS Length (in)	N/A
N/A	Landing X Slope (%)	N/A	N/A	DWS Full Width?	N/A
N/A	Landing Curb? (Y/N)	N/A	N/A	DWS Offset (in)	N/A
N/A	Shared Landing?	N/A			
N/A	Gutter Ponding?	N/A	N/A	Gutter Slope (%)	N/A
N/A	Gutter Lip Ht (in)	N/A	N/A	Gutter X Slope (%)	N/A
N/A	Painted X Walk1?	No	N/A	Painted X Walk2?	No
	X Walk 1 Direction	To SW		X Walk 2 Direction	To SE
N/A	X Walk 1 Width (in)	N/A	N/A	X Walk 2 Width (in)	N/A
	X Walk 1 Slope (%)	3.7		X Walk 2 Slope (%)	4.6
	X Walk 1 X Slope (%)	1.6		X Walk 2 X Slope (%)	0.6

N/A	Ramp inside XWalk1?	N/A	N/A	Ramp inside XWalk2?	N/A
	Road Slope (%)	2.2	N/A	Clear Space?	N/A
	Road X Slope (%)	3.6	N/A	Clear Space to XWalk (in)	N/A
N/A	Any Obstructions?	N/A	N/A	Storm Grate/Utility Hazard?	N/A
	Obstruction Type			Storm Grate/Utility Type	
		N/A			N/A
		Yes		Surface Condition? (G/P)	Good

**Remove & Replace Curb Ramp With Two New Directional Ramps or Equivalent.**

**R304.2.2**

Total Cost: \$ 3200.00
