Access Compliance Report

Public Rights-of-Way

(Curb Ramps)

Intersection ID: 9339	Main Street: BADGER_CT	Cross Street: WOODWARD_AV	Location: SW
ADA ID: BC0482756D7D	Ramp Type: Perp	Initial Pass/Fail: Fail	Overall Compliance: No
		Severity Score: 12.5

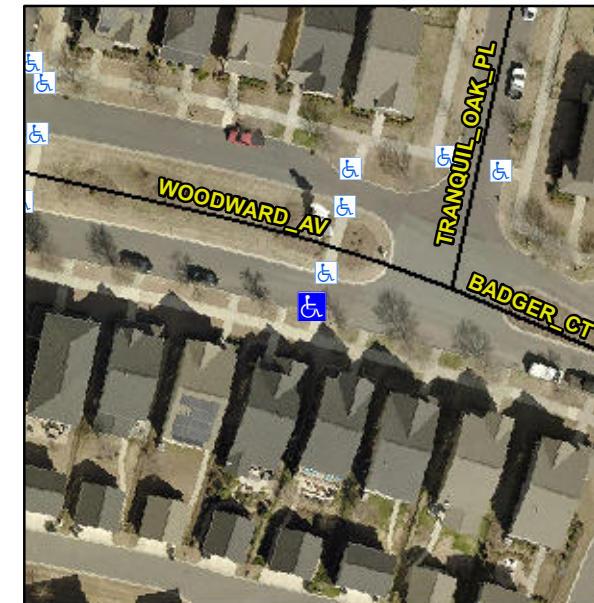
Not Found, R304.5.3

Compliance	Description	Data	Compliance	Description	Data
N/A	Ramp Length (in)	176.0	Yes	Ramp Slope (%)	6.9
Yes	Ramp Width (in)	52.5	No	Ramp XSlope (%)	5.2
N/A	Flare Type LT	N/A	N/A	Flare Type RT	N/A
N/A	Flare Slope LT (%)	N/A	N/A	Flare Slope RT (%)	N/A
N/A	Flare Traversable LT?	N/A	N/A	Flare Traversable RT?	N/A
N/A	Landing Length (in)	N/A	N/A	DWS Provided?	N/A
N/A	Landing Width (in)	N/A	N/A	DWS Contrast?	N/A
N/A	Landing Slope (%)	N/A	N/A	DWS Length (in)	N/A
N/A	Landing X Slope (%)	N/A	N/A	DWS Full Width?	N/A
N/A	Landing Curb? (Y/N)	N/A	N/A	DWS Offset (in)	N/A
N/A	Shared Landing?	N/A			
N/A	Gutter Ponding?	N/A	N/A	Gutter Slope (%)	N/A
N/A	Gutter Lip Ht (in)	N/A	N/A	Gutter X Slope (%)	N/A
N/A	Painted X Walk1?	No	N/A	Painted X Walk2?	N/A
	X Walk 1 Direction	To N		X Walk 2 Direction	N/A
N/A	X Walk 1 Width (in)	N/A	N/A	X Walk 2 Width (in)	N/A
	X Walk 1 Slope (%)	2.2		X Walk 2 Slope (%)	N/A
	X Walk 1 X Slope (%)	4.3		X Walk 2 X Slope (%)	N/A

Possible Solutions:

Remove & Replace Entire Ramp.

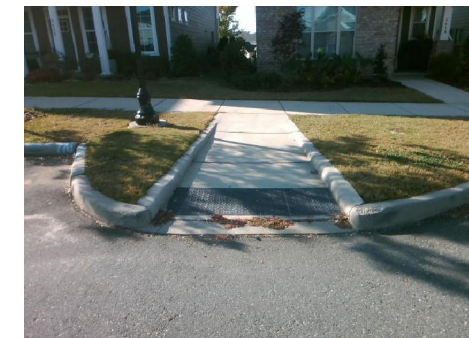
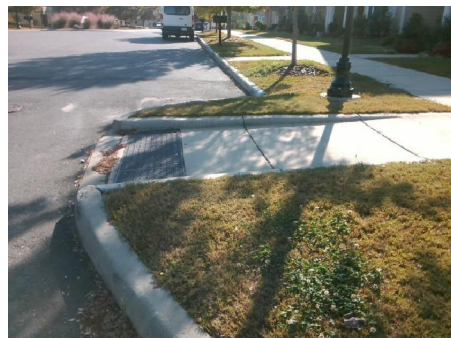
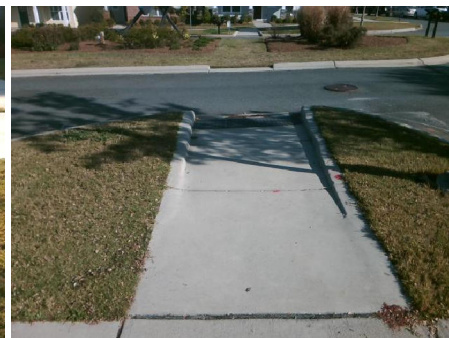
N/A	Ramp inside XWalk1?	N/A	N/A	Ramp inside XWalk2?	N/A
	Road Slope (%)	N/A	N/A	Clear Space?	N/A
	Road X Slope (%)	N/A	N/A	Clear Space to XWalk (in)	N/A
N/A	Any Obstructions?	N/A	N/A	Storm Grate/Utility Hazard?	N/A
	Obstruction Type			Storm Grate/Utility Type	
		N/A			N/A
			Yes	Surface Condition? (G/P)	Good
