Access Compliance Report

Public Rights-of-Way

(Curb Ramps)

Intersection ID: 53624	Main Street: PROSPERITY RIDGE RD	Cross Street: RIDGE RD	Location: NW
ADA ID: BC0F8ED72C66	Ramp Type: Directional1	Initial Pass/Fail: Fail	Overall Compliance: No
			Severity Score: 13.75

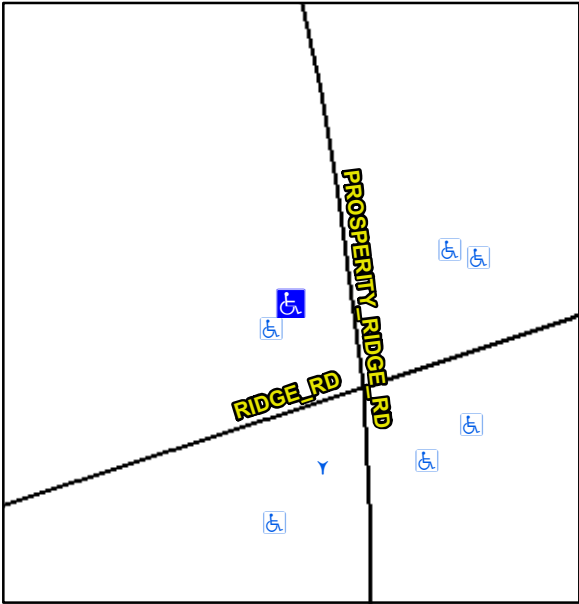
Possible Solutions:		Compliance	Description	Data	Compliance	Description	Data
	Remove & Replace Entire Ramp.		N/A	Ramp Length (in)	129.0	N/A	Grade Break?	N/A
			Yes	Ramp Width (in)	68.0	N/A	Grade Break Slope (%)	0.0
			No	Ramp Slope (%)	10.5	N/A	Grade Break XSlope (%)	0.0
			No	Ramp XSlope (%)	2.2			
			N/A	Flare Type LT	N/A	N/A	Flare Type RT	N/A
			N/A	Flare Slope LT (%)	N/A	N/A	Flare Slope RT (%)	0.0
			N/A	Flare Traversable LT?	N/A	N/A	Flare Traversable RT?	N/A
	Surveyor Notes:		N/A	Landing Length (in)	0.0	N/A	DWS Provided?	N/A
				Landing Width (in)	0.0	N/A	DWS Contrast?	N/A
			Landing Slope (%)	0.0	N/A	DWS Length (in)	N/A	
			Landing X Slope (%)	0.0	N/A	DWS Full Width?	N/A	
PROW/ADA:		N/A	Landing Curb? (Y/N)	N/A	N/A	DWS Offset LT (in)	N/A	
		R304.2.2, R304.5.3	N/A	Shared Landing?	N/A	N/A	DWS Offset RT (in)	N/A

N/A	Gutter Ponding?	0.0	N/A	Gutter Slope (%)	N/A
			N/A	Gutter Lip Ht (in)	0.0	N/A	Gutter X Slope (%)	N/A
			N/A	Painted X Walk1?	Yes		Road Slope (%)	1.2
				X Walk 1 Direction	To NE		Road X Slope (%)	2.1
				X Walk 1 Width (in)	113.5		Clear Space?	N/A
				X Walk 1 Slope (%)	1.2	N/A	Clear Space to XWalk (in)	N/A
				X Walk 1 X Slope (%)	2.1	N/A	Storm Grate/Utility Hazard?	N/A
			N/A	Ramp inside XWalk1?	Yes		Storm Grate/Utility Type	
			N/A	Any Obstructions?	N/A			N/A
				Obstruction Type		Yes	Surface Condition? (G/P)	Good
					N/A	N/A	Curb Slope (%)	N/A
Total Cost:		\$ 1600.00						
Street 1 Name			PROSPERITY RIDGE RD					
Stop Condition-Street 1			Signal					
Street 2 Name			N/A					
Stop Condition-Street 2			N/A
