## Access Compliance Report Public Rights-of-Way (Curb Ramps)

Intersection ID: 24051 Main Street: DEHAVILLAND\_DR Cross Street: SILVER\_DART\_PL Location: SW

ADA ID: BC16DEB70B2D Ramp Type: PerpDiag Initial Pass/Fail: Fail Overall Compliance: No Severity Score: 12.5

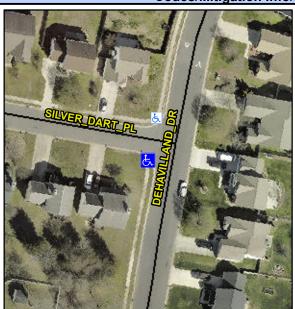
Field Measurements/Component Compilance						
	Compli	Compliance Description		Compliance Description		Data
	N/A	Ramp Length (in)	96.0	Yes	Ramp Slope (%)	6.0
	Yes	Ramp Width (in)	53.0	No	Ramp XSlope (%)	5.9
	N/A	Flare Type LT	N/A	N/A	Flare Type RT	N/A
	N/A	Flare Slope LT (%)	N/A	N/A	Flare Slope RT (%)	N/A
	N/A	Flare Traversable LT?	N/A	N/A	Flare Traversable RT?	N/A
	N/A	Landing Length (in)	N/A	N/A	DWS Provided?	N/A
	N/A	Landing Width (in)	N/A	N/A	DWS Contrast?	N/A
	N/A	Landing Slope (%)	N/A	N/A	DWS Length (in)	N/A
	N/A	Landing X Slope (%)	N/A	N/A	DWS Full Width?	N/A
	N/A	Landing Curb? (Y/N)	N/A	N/A	DWS Offset (in)	N/A
	N/A	Shared Landing?	N/A			
	N/A	Gutter Ponding?	N/A	N/A	Gutter Slope (%)	N/A
	N/A	Gutter Lip Ht (in)	N/A	N/A	Gutter X Slope (%)	N/A
	N/A	Painted X Walk1?	No	N/A	Painted X Walk2?	No
		X Walk 1 Direction	To SE		X Walk 2 Direction	To NE
	N/A	X Walk 1 Width (in)	N/A	N/A	X Walk 2 Width (in)	N/A
		X Walk 1 Slope (%)	2.5		X Walk 2 Slope (%)	0.3

X Walk 1 X Slope (%)	0.9		X Walk 2 X Slope (%)	5.6
	N/A	Ramp inside XWalk1?	N/A	N/A	Ramp inside XWalk2?	N/A
		Road Slope (%)	3.0	N/A	Clear Space?	N/A
		Road X Slope (%)	2.4	N/A	Clear Space to XWalk (in)	N/A
	N/A	Any Obstructions?	N/A	N/A	Storm Grate/Utility Hazard?	N/A
		Obstruction Type			Storm Grate/Utility Type	
			N/A			N/A
				Yes	Surface Condition? (G/P)	Good

Possible Solutions:

Remove & Replace Curb Ramp With

Two New Directional Ramps or Equivalent.

PROW/ADA:
R304.5.3
