Access Compliance Report Public Rights-of-Way (Curb Ramps)

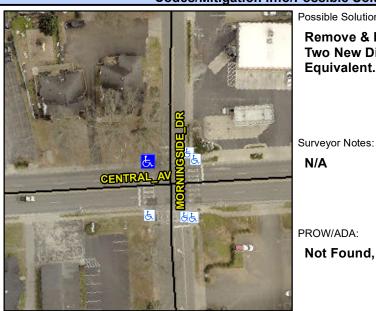
Intersection ID: 13296 Main Street: CENTRAL AV **Cross Street: MORNINGSIDE DR** Location: NW ADA ID: BC2587EC1612 Ramp Type: PerpDiag Initial Pass/Fail: Fail **Overall Compliance: No Severity Score:** 8.75

Field Measurements/Component Compliance					
Compliance Description		Data	Comp	liance Description	Data
N/A	Ramp Length (in)	54.0	Yes	Ramp Slope (%)	5.7
No	Ramp Width (in)	45.0	Yes	Ramp XSlope (%)	1.1
N/A	Flare Type LT	N/A	N/A	Flare Type RT	N/A
N/A	Flare Slope LT (%)	N/A	N/A	Flare Slope RT (%)	N/A
N/A	Flare Traversable LT?	N/A	N/A	Flare Traversable RT?	N/A
N/A	Landing Length (in)	N/A	N/A	DWS Provided?	N/A
N/A	Landing Width (in)	N/A	N/A	DWS Contrast?	N/A
N/A	Landing Slope (%)	N/A	N/A	DWS Length (in)	N/A
N/A	Landing X Slope (%)	N/A	N/A	DWS Full Width?	N/A
N/A	Landing Curb? (Y/N)	N/A	N/A	DWS Offset (in)	N/A
N/A	Shared Landing?	N/A			
N/A	Gutter Ponding?	Yes	N/A	Gutter Slope (%)	N/A
N/A	Gutter Lip Ht (in)	N/A	N/A	Gutter X Slope (%)	N/A
N/A	Painted X Walk1?	Yes	N/A	Painted X Walk2?	Yes
	X Walk 1 Direction	To S		X Walk 2 Direction	To E
N/A	X Walk 1 Width (in)	110.0	N/A	X Walk 2 Width (in)	109.0
	X Walk 1 Slope (%)	3.2		X Walk 2 Slope (%)	0.4

X Walk 1 X Slope (%)	1.0		X Walk 2 X Slope (%)	1.1
N/A	Ramp inside XWalk1?	Yes	N/A	Ramp inside XWalk2?	Yes
	Road Slope (%)	3.7	N/A	Clear Space?	N/A
	Road X Slope (%)	0.1	N/A	Clear Space to XWalk (in)	N/A
N/A	Any Obstructions?	N/A	N/A	Storm Grate/Utility Hazard?	N/A
	Obstruction Type			Storm Grate/Utility Type	
		N/A			N/A
			Yes	Surface Condition? (G/P)	Good

Possible Solutions: Remove & Replace Curb Ramp With **Two New Directional Ramps or** Equivalent.
