## **Access Compliance Report Public Rights-of-Way** (Curb Ramps)

Intersection ID: 17650 Main Street: CRESTHILL DR Cross Street: IDLEWILD RD Location: SW **Overall Compliance: No Severity Score:** ADA ID: BC27DF242C0E Ramp Type: BlendTrans2 Initial Pass/Fail: Fail 1.25

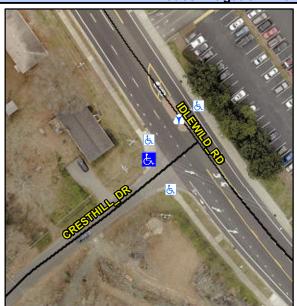
Not Found, R304.5.3

Total Cost: 3200.00 Compliance Description Compliance Description Data 125.0 Yes BlendTrans Slope (%) N/A Ramp Length (in) 2.2 No Yes Ramp Width (in) 55.0 BlendTrans XSlope (%) 3.6 N/A N/A Flare Type LT N/A Flare Type RT N/A N/A Flare Slope LT (%) N/A N/A Flare Slope RT (%) N/A N/A Flare Traversable LT? N/A N/A Flare Traversable RT? N/A N/A N/A N/A **DWS Provided?** N/A Landing Length (in) N/A Landing Width (in) N/A N/A **DWS Contrast?** N/A N/A N/A N/A Landing Slope (%) DWS Length (in) N/A N/A Landing X Slope (%) N/A N/A DWS Full Width? N/A N/A Landing Curb? (Y/N) N/A N/A DWS Offset (in) N/A N/A N/A Shared Landing? N/A **Gutter Ponding?** N/A N/A Gutter Slope (%) N/A N/A Gutter Lip Ht (in) N/A N/A Gutter X Slope (%) N/A N/A Painted X Walk1? No N/A Painted X Walk2? N/A X Walk 1 Direction To SE X Walk 2 Direction N/A N/A X Walk 1 Width (in) X Walk 2 Width (in) N/A X Walk 1 Slope (%) 0.1 X Walk 2 Slope (%) N/A X Walk 2 X Slope (%) X Walk 1 X Slope (%) 3.1 N/A N/A N/A Ramp inside XWalk2? N/A Ramp inside XWalk1? N/A Road Slope (%) 3.1 Clear Space? N/A Road X Slope (%) 0.1 N/A Clear Space to XWalk (in) N/A N/A N/A N/A Any Obstructions? Storm Grate/Utility Hazard? N/A **Obstruction Type** Storm Grate/Utility Type N/A N/A Yes Surface Condition? (G/P) Good

Remove & Replace Curb Ramp With Two New Directional Ramps or Equivalent.
