# Access Compliance Report

## Public Rights-of-Way

### (Curb Ramps)

Intersection ID: 12342	Main Street: E_8TH_ST	Cross Street: N_CALDWELL_ST	Location: N
ADA ID: BC285CBA96A5	Ramp Type: Perp	Initial Pass/Fail: Fail	Overall Compliance: No
Severity Score: 22.5			
Codes/Mitigation Info/Possible Solution		Field Measurements/Component Compliance

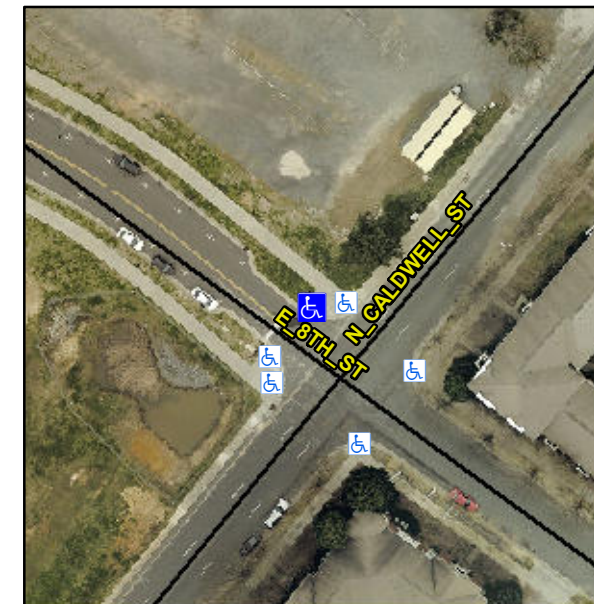
**Not Found, R304.5.1, R304.2.2, R304.5.3**

Compliance	Description	Data	Compliance	Description	Data
N/A	Ramp Length (in)	72.5	No	Ramp Slope (%)	10.8
No	Ramp Width (in)	47.5	No	Ramp XSlope (%)	2.4
N/A	Flare Type LT	N/A	N/A	Flare Type RT	N/A
N/A	Flare Slope LT (%)	N/A	N/A	Flare Slope RT (%)	N/A
N/A	Flare Traversable LT?	N/A	N/A	Flare Traversable RT?	N/A
N/A	Landing Length (in)	N/A	N/A	DWS Provided?	N/A
N/A	Landing Width (in)	N/A	N/A	DWS Contrast?	N/A
N/A	Landing Slope (%)	N/A	N/A	DWS Length (in)	N/A
N/A	Landing X Slope (%)	N/A	N/A	DWS Full Width?	N/A
N/A	Landing Curb? (Y/N)	N/A	N/A	DWS Offset (in)	N/A
N/A	Shared Landing?	N/A			
N/A	Gutter Ponding?	N/A	N/A	Gutter Slope (%)	N/A
N/A	Gutter Lip Ht (in)	N/A	N/A	Gutter X Slope (%)	N/A
N/A	Painted X Walk1?	No	N/A	Painted X Walk2?	N/A
	X Walk 1 Direction	To SW		X Walk 2 Direction	N/A
N/A	X Walk 1 Width (in)	N/A	N/A	X Walk 2 Width (in)	N/A
	X Walk 1 Slope (%)	2.0		X Walk 2 Slope (%)	N/A
	X Walk 1 X Slope (%)	2.1		X Walk 2 X Slope (%)	N/A

N/A	Ramp inside XWalk1?	N/A	N/A	Ramp inside XWalk2?	N/A
	Road Slope (%)	N/A	N/A	Clear Space?	N/A
	Road X Slope (%)	N/A	N/A	Clear Space to XWalk (in)	N/A
N/A	Any Obstructions?	N/A	N/A	Storm Grate/Utility Hazard?	N/A
	Obstruction Type			Storm Grate/Utility Type	
		N/A			N/A
			Yes	Surface Condition? (G/P)	Good

**Remove & Replace Entire Ramp.**
