Access Compliance Report

Public Rights-of-Way

(Curb Ramps)

Intersection ID: 5073	Main Street: FROSTMOOR_PL	Cross Street: HEDGECREST_PL	Location: SE
ADA ID: BC2C03FBC06C	Ramp Type: Perp	Initial Pass/Fail: Fail	Overall Compliance: No
Severity Score: 33.75			
Codes/Mitigation Info/Possible Solution		Field Measurements/Component Compliance

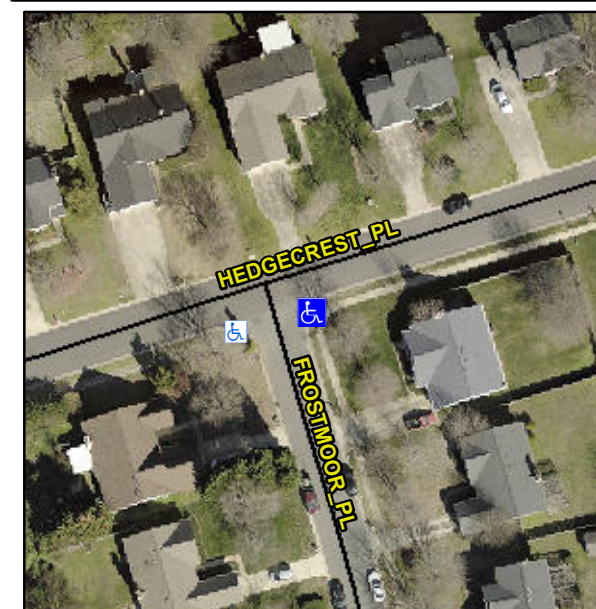
Not Found, R304.5.1, R304.2.2, R304.5.3

Compliance	Description	Data	Compliance	Description	Data
N/A	Ramp Length (in)	46.5	No	Ramp Slope (%)	9.4
No	Ramp Width (in)	44.0	No	Ramp XSlope (%)	6.6
N/A	Flare Type LT	N/A	N/A	Flare Type RT	N/A
N/A	Flare Slope LT (%)	N/A	N/A	Flare Slope RT (%)	N/A
N/A	Flare Traversable LT?	N/A	N/A	Flare Traversable RT?	N/A
N/A	Landing Length (in)	N/A	N/A	DWS Provided?	N/A
N/A	Landing Width (in)	N/A	N/A	DWS Contrast?	N/A
N/A	Landing Slope (%)	N/A	N/A	DWS Length (in)	N/A
N/A	Landing X Slope (%)	N/A	N/A	DWS Full Width?	N/A
N/A	Landing Curb? (Y/N)	N/A	N/A	DWS Offset (in)	N/A
N/A	Shared Landing?	N/A			
N/A	Gutter Ponding?	N/A	N/A	Gutter Slope (%)	N/A
N/A	Gutter Lip Ht (in)	N/A	N/A	Gutter X Slope (%)	N/A
N/A	Painted X Walk1?	No	N/A	Painted X Walk2?	N/A
	X Walk 1 Direction	To W		X Walk 2 Direction	N/A
N/A	X Walk 1 Width (in)	N/A	N/A	X Walk 2 Width (in)	N/A
	X Walk 1 Slope (%)	3.4		X Walk 2 Slope (%)	N/A
	X Walk 1 X Slope (%)	3.2		X Walk 2 X Slope (%)	N/A

N/A	Ramp inside XWalk1?	N/A	N/A	Ramp inside XWalk2?	N/A
	Road Slope (%)	N/A	N/A	Clear Space?	N/A
	Road X Slope (%)	N/A	N/A	Clear Space to XWalk (in)	N/A
N/A	Any Obstructions?	N/A	N/A	Storm Grate/Utility Hazard?	N/A
	Obstruction Type			Storm Grate/Utility Type	
		N/A			N/A
			Yes	Surface Condition? (G/P)	Good

Possible Solutions:

Remove & Replace Entire Ramp.
