Access Compliance Report

Public Rights-of-Way

(Curb Ramps)

Intersection ID: 10077	Main Street: E_35TH_ST	Cross Street: N_DAVIDSON_ST	Location: SE
ADA ID: BC3669640242	Ramp Type: PerpDiag	Initial Pass/Fail: Fail	Overall Compliance: No
Severity Score: 13.75			
Codes/Mitigation Info/Possible Solution		Field Measurements/Component Compliance

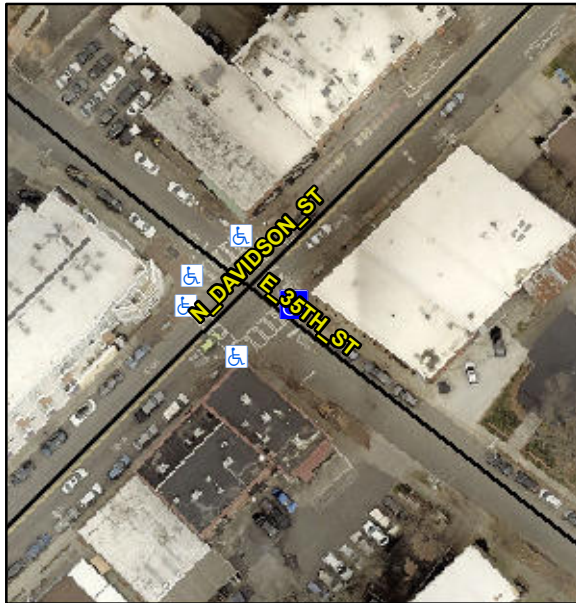
R304.2.2, R304.5.3

Compliance	Description	Data	Compliance	Description	Data
N/A	Ramp Length (in)	78.0	No	Ramp Slope (%)	9.5
Yes	Ramp Width (in)	48.0	No	Ramp XSlope (%)	2.6
N/A	Flare Type LT	N/A	N/A	Flare Type RT	N/A
N/A	Flare Slope LT (%)	N/A	N/A	Flare Slope RT (%)	N/A
N/A	Flare Traversable LT?	N/A	N/A	Flare Traversable RT?	N/A
N/A	Landing Length (in)	N/A	N/A	DWS Provided?	N/A
N/A	Landing Width (in)	N/A	N/A	DWS Contrast?	N/A
N/A	Landing Slope (%)	N/A	N/A	DWS Length (in)	N/A
N/A	Landing X Slope (%)	N/A	N/A	DWS Full Width?	N/A
N/A	Landing Curb? (Y/N)	N/A	N/A	DWS Offset (in)	N/A
N/A	Shared Landing?	N/A			
N/A	Gutter Ponding?	N/A	N/A	Gutter Slope (%)	N/A
N/A	Gutter Lip Ht (in)	1.0	N/A	Gutter X Slope (%)	N/A
N/A	Painted X Walk1?	Yes	N/A	Painted X Walk2?	Yes
	X Walk 1 Direction	To NW		X Walk 2 Direction	To SW
N/A	X Walk 1 Width (in)	74.0	N/A	X Walk 2 Width (in)	111.0
	X Walk 1 Slope (%)	2.5		X Walk 2 Slope (%)	0.5
	X Walk 1 X Slope (%)	1.9		X Walk 2 X Slope (%)	2.4

N/A	Ramp inside XWalk1?	Yes	N/A	Ramp inside XWalk2?	Yes
	Road Slope (%)	2.5	N/A	Clear Space?	N/A
	Road X Slope (%)	1.1	N/A	Clear Space to XWalk (in)	N/A
N/A	Any Obstructions?	N/A	N/A	Storm Grate/Utility Hazard?	N/A
	Obstruction Type			Storm Grate/Utility Type	
		N/A			N/A
		Yes		Surface Condition? (G/P)	Good

Possible Solutions:

Remove & Replace Curb Ramp With Two New Directional Ramps or Equivalent.

Total Cost: \$ 3200.00
