# Access Compliance Report

## Public Rights-of-Way

| Intersection ID: 21948 | Main Street: SARDIS_RD | Cross Street: SARDIS_RD_NORTH | Location: NE |
| ADA ID: BC36D7F57F53 | Ramp Type: PerpDiag | Initial Pass/Fail: Fail | Overall Compliance: No |

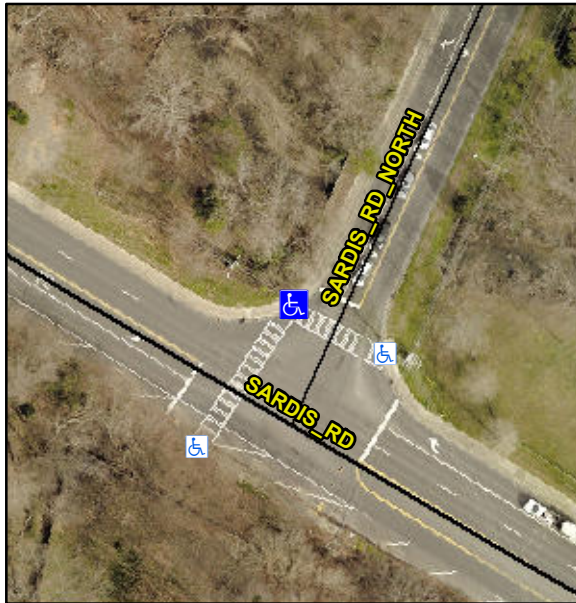
| | | Severity Score: 12.5 | |

**Not Found, R304.2.2**

| Compliance | Description | Data | Compliance | Description | Data |
|---|---|---|---|---|---|
| N/A | Ramp Length (in) | 61.0 | No | Ramp Slope (%) | 10.1 |

**Remove & Replace Curb Ramp With Two New Directional Ramps or Equivalent.**
