# Access Compliance Report

## Public Rights-of-Way

### (Curb Ramps)

Intersection ID: 44118	Main Street: CORAM_PL	Cross Street: RIDING_HILL_AV	Location: SW
ADA ID: BC3B716A4577	Ramp Type: PerpDiag	Initial Pass/Fail: Fail	Overall Compliance: No
Severity Score: 46.25			
Codes/Mitigation Info/Possible Solution		Field Measurements/Component Compliance

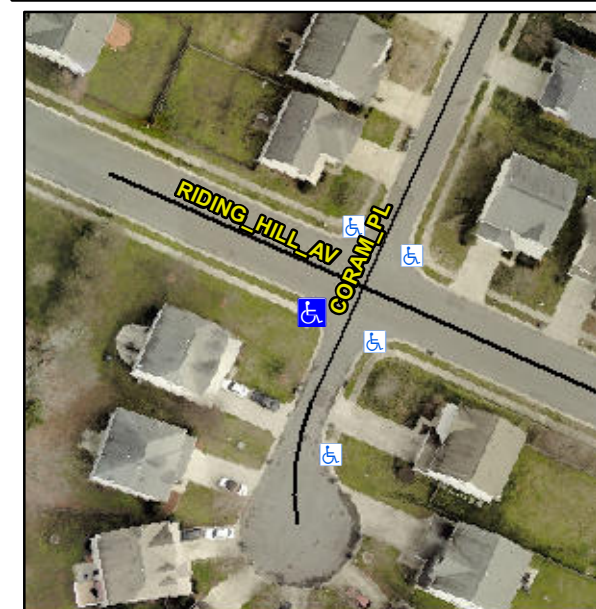
**Not Found, R304.5.1, R304.2.2, R304.5.3**

Compliance	Description	Data	Compliance	Description	Data
N/A	Ramp Length (in)	48.0	No	Ramp Slope (%)	11.4
No	Ramp Width (in)	38.0	No	Ramp XSlope (%)	7.1
N/A	Flare Type LT	N/A	N/A	Flare Type RT	N/A
N/A	Flare Slope LT (%)	N/A	N/A	Flare Slope RT (%)	N/A
N/A	Flare Traversable LT?	N/A	N/A	Flare Traversable RT?	N/A
N/A	Landing Length (in)	N/A	N/A	DWS Provided?	N/A
N/A	Landing Width (in)	N/A	N/A	DWS Contrast?	N/A
N/A	Landing Slope (%)	N/A	N/A	DWS Length (in)	N/A
N/A	Landing X Slope (%)	N/A	N/A	DWS Full Width?	N/A
N/A	Landing Curb? (Y/N)	N/A	N/A	DWS Offset (in)	N/A
N/A	Shared Landing?	N/A			
N/A	Gutter Ponding?	N/A	N/A	Gutter Slope (%)	N/A
N/A	Gutter Lip Ht (in)	N/A	N/A	Gutter X Slope (%)	N/A
N/A	Painted X Walk1?	No	N/A	Painted X Walk2?	No
	X Walk 1 Direction	To SE		X Walk 2 Direction	To NE
N/A	X Walk 1 Width (in)	N/A	N/A	X Walk 2 Width (in)	N/A
	X Walk 1 Slope (%)	0.7		X Walk 2 Slope (%)	2.2
	X Walk 1 X Slope (%)	3.5		X Walk 2 X Slope (%)	4.6

N/A	Ramp inside XWalk1?	N/A	N/A	Ramp inside XWalk2?	N/A
	Road Slope (%)	4.8	N/A	Clear Space?	N/A
	Road X Slope (%)	3.9	N/A	Clear Space to XWalk (in)	N/A
N/A	Any Obstructions?	N/A	N/A	Storm Grate/Utility Hazard?	N/A
	Obstruction Type			Storm Grate/Utility Type	
		N/A			N/A
			Yes	Surface Condition? (G/P)	Good

**Remove & Replace Curb Ramp With Two New Directional Ramps or Equivalent.**

Total Cost: \$ 3200.00
