Access Compliance Report

Public Rights-of-Way

(Curb Ramps)

Intersection ID: 5420	Main Street: CARVER_PL	Cross Street: ROCKWELL_BV_WEST	Location: W
ADA ID: BC429DFA5C53	Ramp Type: Para	Initial Pass/Fail: Fail	Overall Compliance: No
Severity Score: 35			
Codes/Mitigation Info/Possible Solution		Field Measurements/Component Compliance

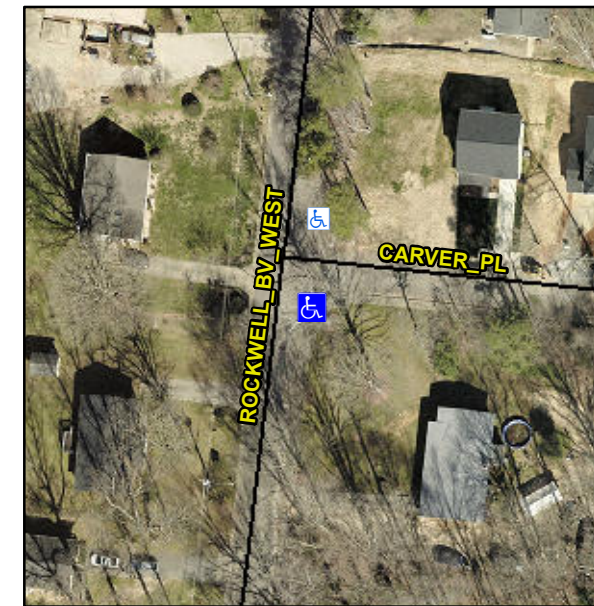
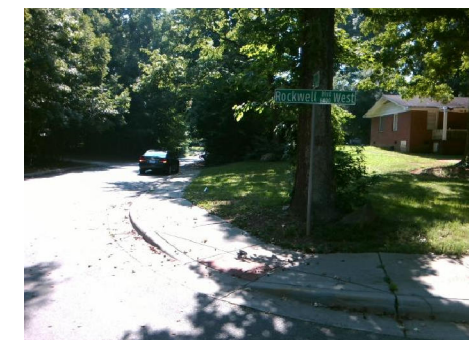
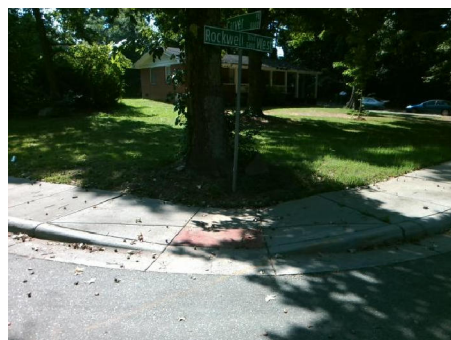
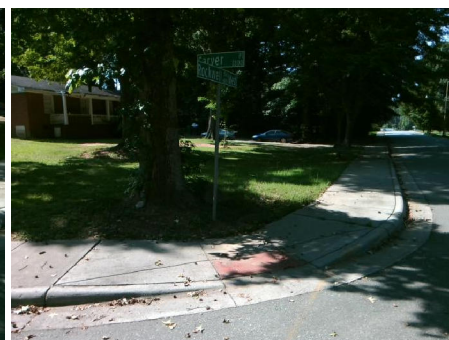
Compliance	Description	Data	Compliance	Description	Data
N/A	Ramp Length LT (in)	55.0	N/A	Ramp Length RT (in)	39.0
No	Ramp Width LT (in)	36.0	No	Ramp Width RT (in)	36.0
Yes	Ramp Slope LT (%)	6.0	No	Ramp Slope RT (%)	19.8
Yes	Ramp XSlope LT (%)	0.7	No	Ramp XSlope RT (%)	3.9
N/A	Landing Length (in)	N/A	N/A	DWS Provided?	N/A
N/A	Landing Width (in)	N/A	N/A	DWS Contrast?	N/A
N/A	Landing Slope (%)	N/A	N/A	DWS Length (in)	N/A
N/A	Landing X Slope (%)	N/A	N/A	DWS Full Width?	N/A
N/A	Landing Curb? (Y/N)	N/A	N/A	DWS Offset (in)	N/A
N/A	Shared Landing?	N/A			
N/A	Gutter Ponding?	N/A	N/A	Gutter Slope (%)	N/A
N/A	Gutter Lip Ht (in)	N/A	N/A	Gutter X Slope (%)	N/A
N/A	Painted X Walk1?	No	N/A	Painted X Walk2?	N/A
	X Walk 1 Direction	To N		X Walk 2 Direction	N/A
N/A	X Walk 1 Width (in)	N/A	N/A	X Walk 2 Width (in)	N/A
	X Walk 1 Slope (%)	0.1		X Walk 2 Slope (%)	N/A
	X Walk 1 X Slope (%)	0.7		X Walk 2 X Slope (%)	N/A
N/A	Ramp inside XWalk1?	N/A	N/A	Ramp inside XWalk2?	N/A

Road Slope (%)	N/A	N/A	Clear Space?	N/A
	Road X Slope (%)	N/A	N/A	Clear Space to XWalk (in)	N/A
N/A	Any Obstructions?	N/A	N/A	Storm Grate/Utility Hazard?	N/A
	Obstruction Type			Storm Grate/Utility Type	
		N/A			N/A
			Yes	Surface Condition? (G/P)	Good
			N/A	Curb Slope (%)	9.3

Remove & Replace Entire Ramp.

R304.5.1, R304.3.2, R304.5.3
