# Access Compliance Report

## Public Rights-of-Way

### (Curb Ramps)

Intersection ID: 9440	Main Street: BRADFORD_DR	Cross Street: EDGEWOOD_RD	Location: S
ADA ID: BC44F6FFE74E	Ramp Type: Perp	Initial Pass/Fail: Fail	Overall Compliance: No
Codes/Mitigation Info/Possible Solution		Field Measurements/Component Compliance	
Severity Score: 13.75

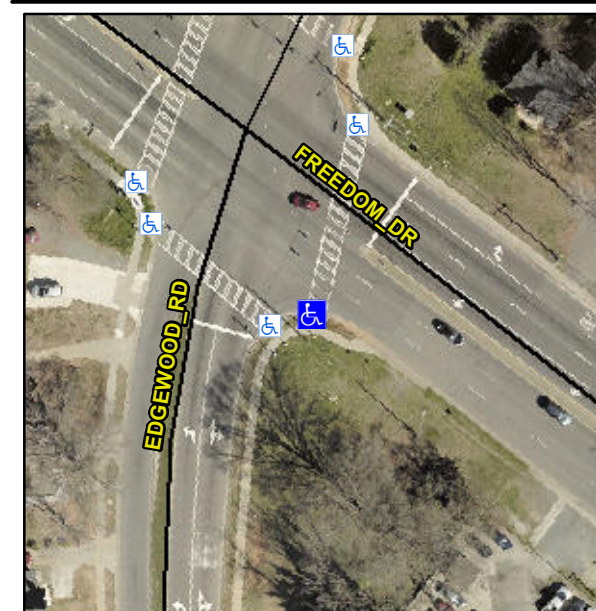
**Not Found, R304.2.2**

Compliance	Description	Data	Compliance	Description	Data
N/A	Ramp Length (in)	60.0	No	Ramp Slope (%)	8.4
Yes	Ramp Width (in)	48.0	Yes	Ramp XSlope (%)	3.6
N/A	Flare Type LT	N/A	N/A	Flare Type RT	N/A
N/A	Flare Slope LT (%)	N/A	N/A	Flare Slope RT (%)	N/A
N/A	Flare Traversable LT?	N/A	N/A	Flare Traversable RT?	N/A
N/A	Landing Length (in)	N/A	N/A	DWS Provided?	N/A
N/A	Landing Width (in)	N/A	N/A	DWS Contrast?	N/A
N/A	Landing Slope (%)	N/A	N/A	DWS Length (in)	N/A
N/A	Landing X Slope (%)	N/A	N/A	DWS Full Width?	N/A
N/A	Landing Curb? (Y/N)	N/A	N/A	DWS Offset (in)	N/A
N/A	Shared Landing?	N/A			
N/A	Gutter Ponding?	N/A	N/A	Gutter Slope (%)	N/A
N/A	Gutter Lip Ht (in)	N/A	N/A	Gutter X Slope (%)	N/A
N/A	Painted X Walk1?	Yes	N/A	Painted X Walk2?	N/A
	X Walk 1 Direction	To NE		X Walk 2 Direction	N/A
N/A	X Walk 1 Width (in)	113.0	N/A	X Walk 2 Width (in)	N/A
	X Walk 1 Slope (%)	3.7		X Walk 2 Slope (%)	N/A
	X Walk 1 X Slope (%)	3.7		X Walk 2 X Slope (%)	N/A

N/A	Ramp inside XWalk1?	Yes	N/A	Ramp inside XWalk2?	N/A
	Road Slope (%)	N/A	N/A	Clear Space?	N/A
	Road X Slope (%)	N/A	N/A	Clear Space to XWalk (in)	N/A
N/A	Any Obstructions?	N/A	N/A	Storm Grate/Utility Hazard?	N/A
	Obstruction Type			Storm Grate/Utility Type	
		N/A			N/A
		Yes		Surface Condition? (G/P)	Good

Possible Solutions:

**Remove & Replace Entire Ramp.**

Total Cost: \$ 1850.00
