Access Compliance Report

Public Rights-of-Way

(Curb Ramps)

Intersection ID: 11882	Main Street: N_PINE_ST	Cross Street: W_5TH_ST	Location: W
ADA ID: BC4A6F5D7B84	Ramp Type: BlendTrans1	Initial Pass/Fail: Pass	Overall Compliance: No
Severity Score: 0.25			
Codes/Mitigation Info/Possible Solution		Field Measurements/Component Compliance

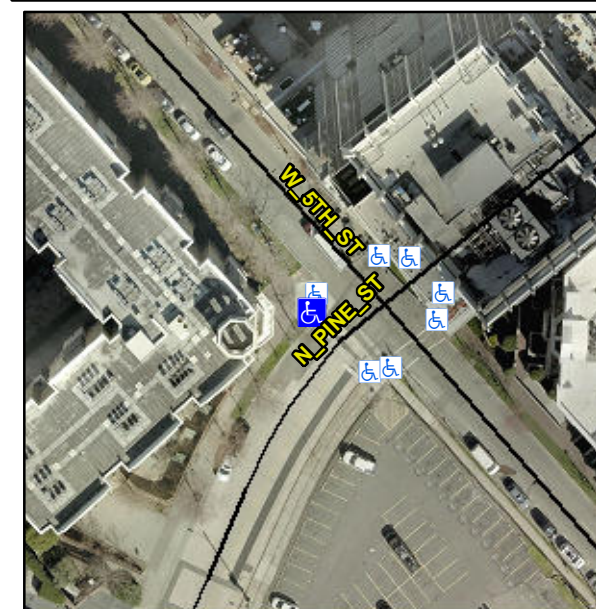
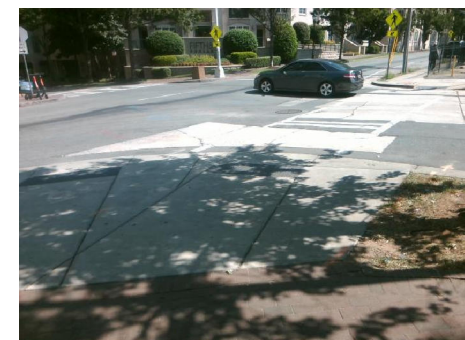
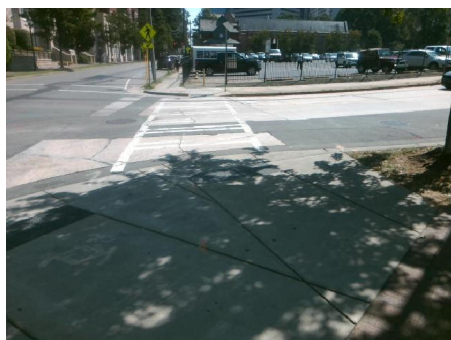
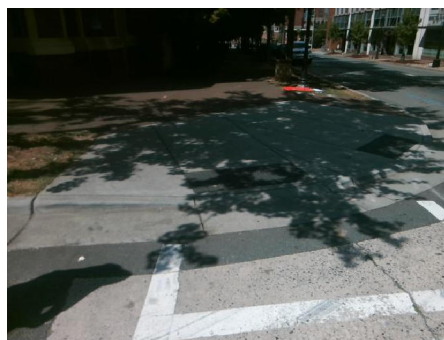
Not Found, R304.5.3, R305.2

Compliance	Description	Data	Compliance	Description	Data
N/A	Ramp Length (in)	123.0	Yes	BlendTrans Slope (%)	1.0
Yes	Ramp Width (in)	60.0	No	BlendTrans XSlope (%)	4.6
N/A	Flare Type LT	Sloped	N/A	Flare Type RT	Sloped
Yes	Flare Slope LT (%)	7.0	Yes	Flare Slope RT (%)	6.3
N/A	Flare Traversable LT?	Yes	N/A	Flare Traversable RT?	Yes
Yes	Landing Length (in)	60.0	Yes	DWS Provided?	Yes
Yes	Landing Width (in)	60.0	Yes	DWS Contrast?	Yes
Yes	Landing Slope (%)	0.3	Yes	DWS Length (in)	24.0
No	Landing X Slope (%)	3.6	Yes	DWS Full Width?	Yes
N/A	Landing Curb? (Y/N)	No	No	DWS Offset (in)	5.0
N/A	Shared Landing?	Yes			
Yes	Gutter Ponding?	No	Yes	Gutter Slope (%)	0.2
Yes	Gutter Lip Ht (in)	0.0	No	Gutter X Slope (%)	3.2
N/A	Painted X Walk1?	Yes	N/A	Painted X Walk2?	N/A
	X Walk 1 Direction	To SE		X Walk 2 Direction	N/A
	X Walk 1 Width (in)	100.0		X Walk 2 Width (in)	N/A
	X Walk 1 Slope (%)	1.3		X Walk 2 Slope (%)	N/A
	X Walk 1 X Slope (%)	4.2		X Walk 2 X Slope (%)	N/A

Yes	Ramp inside XWalk1?	Yes	N/A	Ramp inside XWalk2?	N/A
	Road Slope (%)	4.2		Clear Space?	Yes
	Road X Slope (%)	1.3	N/A	Clear Space to XWalk (in)	N/A
Yes	Any Obstructions?	No	Yes	Storm Grate/Utility Hazard?	No
	Obstruction Type			Storm Grate/Utility Type	
		N/A			N/A
			Yes	Surface Condition? (G/P)	Good
			No	Curb Slope (%)	9.5

Remove & Replace Curb Ramp With Two New Directional Ramps or Equivalent. Remove & Replace Gutter.
