Access Compliance Report

Public Rights-of-Way

(Curb Ramps)

Intersection ID: 49147	Main Street: SAINTE_ROSE_LN	Cross Street: OLD_PROVIDENCE_LN	Location: SE
ADA ID: BC5AA4CD6BA6	Ramp Type: PerpDiag	Initial Pass/Fail: Fail	Overall Compliance: No
		Severity Score: 50

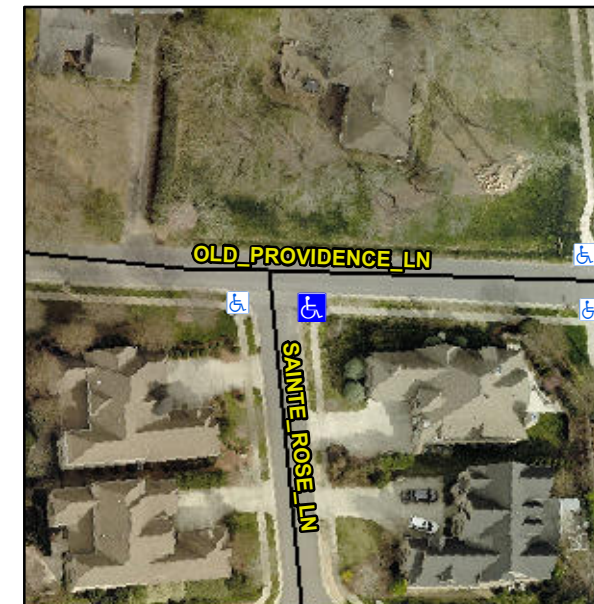
Not Found, R304.2.2, R304.5.3

Compliance	Description	Data	Compliance	Description	Data
N/A	Ramp Length (in)	48.0	No	Ramp Slope (%)	12.4
Yes	Ramp Width (in)	48.0	No	Ramp XSlope (%)	8.1
N/A	Flare Type LT	N/A	N/A	Flare Type RT	N/A
N/A	Flare Slope LT (%)	N/A	N/A	Flare Slope RT (%)	N/A
N/A	Flare Traversable LT?	N/A	N/A	Flare Traversable RT?	N/A
N/A	Landing Length (in)	N/A	N/A	DWS Provided?	N/A
N/A	Landing Width (in)	N/A	N/A	DWS Contrast?	N/A
N/A	Landing Slope (%)	N/A	N/A	DWS Length (in)	N/A
N/A	Landing X Slope (%)	N/A	N/A	DWS Full Width?	N/A
N/A	Landing Curb? (Y/N)	N/A	N/A	DWS Offset (in)	N/A
N/A	Shared Landing?	N/A			
N/A	Gutter Ponding?	N/A	N/A	Gutter Slope (%)	N/A
N/A	Gutter Lip Ht (in)	N/A	N/A	Gutter X Slope (%)	N/A
N/A	Painted X Walk1?	No	N/A	Painted X Walk2?	No
	X Walk 1 Direction	To N		X Walk 2 Direction	To NW
N/A	X Walk 1 Width (in)	N/A	N/A	X Walk 2 Width (in)	N/A
	X Walk 1 Slope (%)	7.1		X Walk 2 Slope (%)	3.2
	X Walk 1 X Slope (%)	3.0		X Walk 2 X Slope (%)	5.5

N/A	Ramp inside XWalk1?	N/A	N/A	Ramp inside XWalk2?	N/A
	Road Slope (%)	4.5	N/A	Clear Space?	N/A
	Road X Slope (%)	1.3	N/A	Clear Space to XWalk (in)	N/A
N/A	Any Obstructions?	N/A	N/A	Storm Grate/Utility Hazard?	N/A
	Obstruction Type			Storm Grate/Utility Type	
		N/A			N/A
			Yes	Surface Condition? (G/P)	Good

Remove & Replace Curb Ramp With Two New Directional Ramps or Equivalent.

Total Cost: \$ 3200.00
