Access Compliance Report Public Rights-of-Way (Curb Ramps)

Intersection ID: 23099 Main Street: MAGGIE LN Cross Street: SHARON_RD_WEST Location: NE ADA ID: BC5AC5AF5412 Ramp Type: PerpDiag Initial Pass/Fail: Fail **Overall Compliance: No Severity Score:** 35

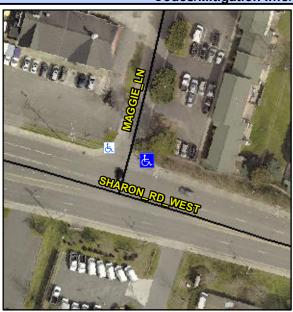
Field Measurements/Component Compliance						
	Compliance Description		Data	Comp	oliance Description	Data
	N/A	Ramp Length (in)	60.0	No	Ramp Slope (%)	13.5
	No	Ramp Width (in)	41.0	No	Ramp XSlope (%)	2.9
	N/A	Flare Type LT	N/A	N/A	Flare Type RT	N/A
	N/A	Flare Slope LT (%)	N/A	N/A	Flare Slope RT (%)	N/A
	N/A	Flare Traversable LT?	N/A	N/A	Flare Traversable RT?	N/A
	N/A	Landing Length (in)	N/A	N/A	DWS Provided?	N/A
	N/A	Landing Width (in)	N/A	N/A	DWS Contrast?	N/A
	N/A	Landing Slope (%)	N/A	N/A	DWS Length (in)	N/A
	N/A	Landing X Slope (%)	N/A	N/A	DWS Full Width?	N/A
	N/A	Landing Curb? (Y/N)	N/A	N/A	DWS Offset (in)	N/A
	N/A	Shared Landing?	N/A			
	N/A	Gutter Ponding?	N/A	N/A	Gutter Slope (%)	N/A
	N/A	Gutter Lip Ht (in)	N/A	N/A	Gutter X Slope (%)	N/A
	N/A	Painted X Walk1?	No	N/A	Painted X Walk2?	No
		X Walk 1 Direction	To NW		X Walk 2 Direction	To S
	N/A	X Walk 1 Width (in)	N/A	N/A	X Walk 2 Width (in)	N/A
		X Walk 1 Slope (%)	5.8		X Walk 2 Slope (%)	1.3

X Walk 1 X Slope (%)	0.5		X Walk 2 X Slope (%)	3.8
	N/A	Ramp inside XWalk1?	N/A	N/A	Ramp inside XWalk2?	N/A
		Road Slope (%)	1.9	N/A	Clear Space?	N/A
		Road X Slope (%)	4.5	N/A	Clear Space to XWalk (in)	N/A
	N/A	Any Obstructions?	N/A	N/A	Storm Grate/Utility Hazard?	N/A
		Obstruction Type			Storm Grate/Utility Type	
			N/A			N/A
				Yes	Surface Condition? (G/P)	Good
	A Academic

Possible Solutions: Remove & Replace Curb Ramp With **Two New Directional Ramps or** Equivalent. Surveyor Notes: N/A PROW/ADA: Not Found, R304.5.1, R304.2.2, R304.5.3
