## **Access Compliance Report Public Rights-of-Way** (Curb Ramps)

Intersection ID: 46694 Main Street: TROTTERS\_RIDGE\_RD Cross Street: OLD\_MEADOW\_RD Location: NE ADA ID: BC5F2898B42E Ramp Type: PerpDiag Initial Pass/Fail: Fail **Overall Compliance: No Severity Score:** 12.5

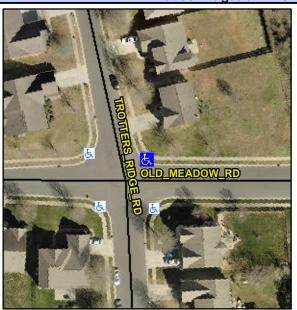
Field Measurements/Component Compliance									
	Compliance Description		Data	Compliance		Description	Data		
	N/A	Ramp Length (in)	48.0	Yes	Ramp	Slope (%)	5.0		
	Yes	Ramp Width (in)	48.0	No	Ramp	XSlope (%)	5.1		
	N/A	Flare Type LT	N/A	N/A	Flare	Type RT	N/A		
	N/A	Flare Slope LT (%)	N/A	N/A	Flare	Slope RT (%)	N/A		
	N/A	Flare Traversable LT?	N/A	N/A	Flare	Traversable RT?	N/A		
	N/A	Landing Length (in)	N/A	N/A	DWS	Provided?	N/A		
	N/A	Landing Width (in)	N/A	N/A	DWS	Contrast?	N/A		
	N/A	Landing Slope (%)	N/A	N/A	DWS	Length (in)	N/A		
	N/A	Landing X Slope (%)	N/A	N/A	DWS	Full Width?	N/A		
	N/A	Landing Curb? (Y/N)	N/A	N/A	DWS	Offset (in)	N/A		
	N/A	Shared Landing?	N/A						
	N/A	Gutter Ponding?	N/A	N/A	Gutte	r Slope (%)	N/A		
	N/A	Gutter Lip Ht (in)	N/A	N/A	Gutte	r X Slope (%)	N/A		
	N/A	Painted X Walk1?	No	N/A	Painte	ed X Walk2?	No		
		X Walk 1 Direction	To W		X Wa	lk 2 Direction	To S		
	N/A	X Walk 1 Width (in)	N/A	N/A	X Wa	lk 2 Width (in)	N/A

X Walk 1 Slope (%)	4.7		X Wa	lk 2 Slope (%)	1.7		
		X Walk 1 X Slope (%)	2.9		X Wa	lk 2 X Slope (%)	6.0		
	N/A	Ramp inside XWalk1?	N/A	N/A	Ramp	inside XWalk2?	N/A		
		Road Slope (%)	6.3	N/A	Clear	Space?	N/A		
		Road X Slope (%)	3.5	N/A	Clear	Space to XWalk (in)	N/A		
	N/A	Any Obstructions?	N/A	N/A	Storm	Grate/Utility Hazard?	N/A		
		Obstruction Type			Storm	Grate/Utility Type			
			N/A				N/A		
				Yes	Surfa	ce Condition? (G/P)	Good		
		Ada and a second

Possible Solution					
Possible Solutions:	С				
Remove & Replace Curb Ramp With					
Two New Directional Ramps or	Ye				
Equivalent.	N				
	N				
	N				
	N				
Surveyor Notes:	N				
N/A	N				
	N				
	N				
	N				
PROW/ADA:					
Not Found, R304.5.3	N				
	N				
	N				
	N

Total Cost: 3200.00
