Access Compliance Report

Public Rights-of-Way

(Curb Ramps)

Intersection ID: 14267	Main Street: CLANTON_RD	Cross Street: FARMER_ST	Location: NE
ADA ID: BC6450977EC7	Ramp Type: Perp	Initial Pass/Fail: Fail	Overall Compliance: No
Severity Score: 35			
Codes/Mitigation Info/Possible Solution		Field Measurements/Component Compliance

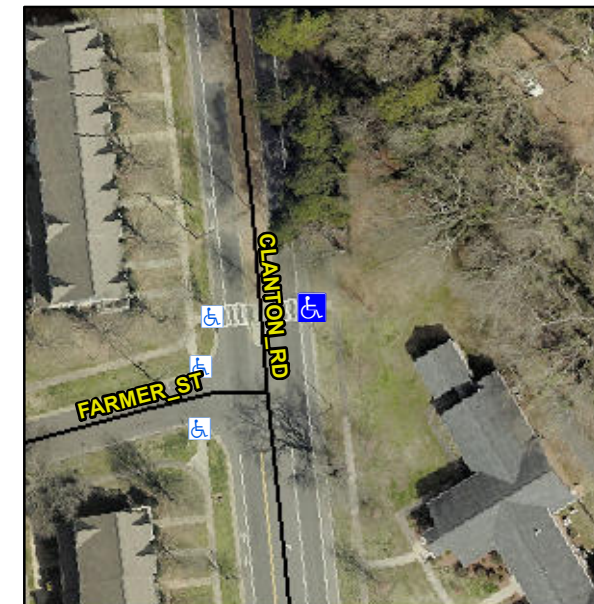
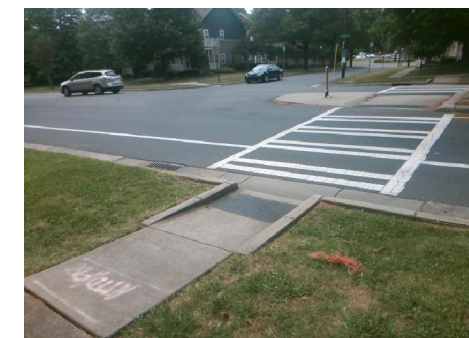
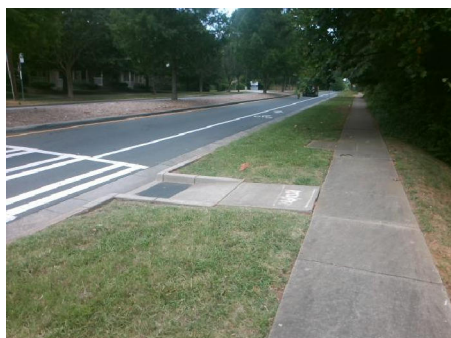
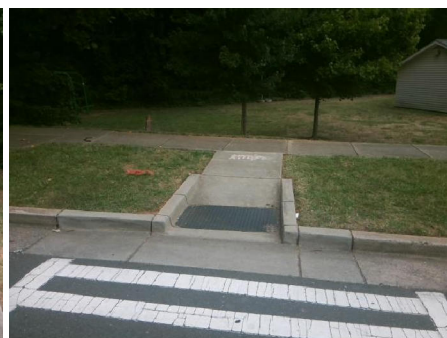
PROW/ADA:

R304.5.1, R304.2.2

Compliance	Description	Data	Compliance	Description	Data
N/A	Ramp Length (in)	112.0	No	Ramp Slope (%)	13.2
No	Ramp Width (in)	47.0	Yes	Ramp XSlope (%)	4.3
N/A	Flare Type LT	N/A	N/A	Flare Type RT	N/A
N/A	Flare Slope LT (%)	N/A	N/A	Flare Slope RT (%)	N/A
N/A	Flare Traversable LT?	N/A	N/A	Flare Traversable RT?	N/A
N/A	Landing Length (in)	N/A	N/A	DWS Provided?	N/A
N/A	Landing Width (in)	N/A	N/A	DWS Contrast?	N/A
N/A	Landing Slope (%)	N/A	N/A	DWS Length (in)	N/A
N/A	Landing X Slope (%)	N/A	N/A	DWS Full Width?	N/A
N/A	Landing Curb? (Y/N)	N/A	N/A	DWS Offset (in)	N/A
N/A	Shared Landing?	N/A			
N/A	Gutter Ponding?	N/A	N/A	Gutter Slope (%)	N/A
N/A	Gutter Lip Ht (in)	N/A	N/A	Gutter X Slope (%)	N/A
N/A	Painted X Walk1?	Yes	N/A	Painted X Walk2?	N/A
	X Walk 1 Direction	To W		X Walk 2 Direction	N/A
N/A	X Walk 1 Width (in)	116.0	N/A	X Walk 2 Width (in)	N/A
	X Walk 1 Slope (%)	4.7		X Walk 2 Slope (%)	N/A
	X Walk 1 X Slope (%)	5.0		X Walk 2 X Slope (%)	N/A

N/A	Ramp inside XWalk1?	Yes	N/A	Ramp inside XWalk2?	N/A
	Road Slope (%)	N/A	N/A	Clear Space?	N/A
	Road X Slope (%)	N/A	N/A	Clear Space to XWalk (in)	N/A
N/A	Any Obstructions?	N/A	N/A	Storm Grate/Utility Hazard?	N/A
	Obstruction Type			Storm Grate/Utility Type	
		N/A			N/A
			Yes	Surface Condition? (G/P)	Good

Possible Solutions:

Remove & Replace Entire Ramp.

Total Cost: \$ 1850.00
