Access Compliance Report Public Rights-of-Way (Curb Ramps)

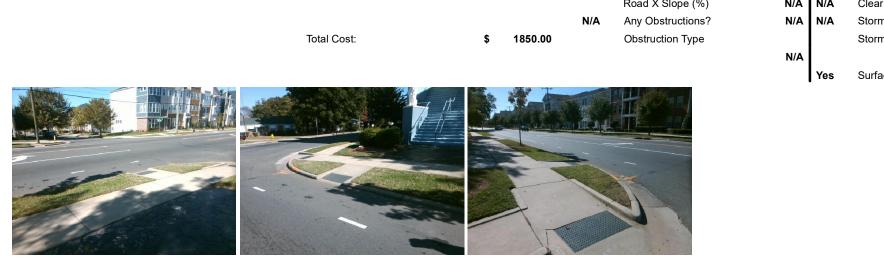
C4		Lesstion	05			
Intersection ID: 9076	6 Main Street: STATESVILLE_AV			Cross	Street:	MORETZ_AV	Location:	SE			
ADA ID: BC69E6F5201C Ramp Type: Perp			Initial	Pass/Fa	ail: Fail Overall C	o Severity Score:	35				
Codes/Mitigation Info/Possible Solution					Field Measurements/Component Compliance						
	1	Possible Solutions:			Compliance Description			Data Compliance Description			
		Remove & Replace Ent	ire Ram).	N/A	Ramp Length (in)	72.5	No	Ramp Slope (%)	13.6	
	160 ES .		•		No	Ramp Width (in)	47.0	No	Ramp XSlope (%)	2.2	
	~				N/A	Flare Type LT	N/A	N/A	Flare Type RT	N/A

R. W.				N/A	Flare Slope LT (%)	N/A	N/A	Flare Slope RT (%)	N/A	
6 6 Mou	at the state				N/A	Flare Traversable LT?	N/A	N/A	Flare Traversable RT?	N/A	
					N/A	Landing Length (in)	N/A	N/A	DWS Provided?	N/A	
PAT GARRETT DI		Surveyor Notes:			N/A	Landing Width (in)	N/A	N/A	DWS Contrast?	N/A	
the state of the s	A second	N/A			N/A	Landing Slope (%)	N/A	N/A	DWS Length (in)	N/A	
<u>6</u>					N/A	Landing X Slope (%)	N/A	N/A	DWS Full Width?	N/A	
	A010				N/A	Landing Curb? (Y/N)	N/A	N/A	DWS Offset (in)	N/A	
	100				N/A	Shared Landing?	N/A				
	100000 100 100	PROW/ADA:			N/A	Gutter Ponding?	N/A	N/A	Gutter Slope (%)	N/A	
		Not Found, R304.5.1, R	304.2.2.		N/A	Gutter Lip Ht (in)	N/A	N/A	Gutter X Slope (%)	N/A	
		R304.5.3	,		N/A	Painted X Walk1?	No	N/A	Painted X Walk2?	N/A	
						X Walk 1 Direction	To W		X Walk 2 Direction	N/A	
					N/A	X Walk 1 Width (in)	N/A	N/A	X Walk 2 Width (in)	N/A	
Street 1 Name ST	ATESVILLE AV	-				X Walk 1 Slope (%)	3.9		X Walk 2 Slope (%)	N/A

Stop Condition-Street 2	None					X Walk 1 X Slope (%)	1.4		X Walk 2 X Slope (%)	N/A	
Street 2 Name	N/A				N/A	Ramp inside XWalk1?	N/A	N/A	Ramp inside XWalk2?	N/A	
Stop Condition-Street 1	N/A					Road Slope (%)	N/A	N/A	Clear Space?	N/A	
						Road X Slope (%)	N/A	N/A	Clear Space to XWalk (in)	N/A	
					N/A	Any Obstructions?	N/A	N/A	Storm Grate/Utility Hazard?	N/A	
		Total Cost:	\$	1850.00		Obstruction Type			Storm Grate/Utility Type		
							N/A			N/A
