Access Compliance Report

Public Rights-of-Way

(Curb Ramps)

Intersection ID: 47613	Main Street: BATHURST_DR	Cross Street: MACQUARIE_LN	Location: SW
ADA ID: BC75089D20BE	Ramp Type: PerpDiag	Initial Pass/Fail: Fail	Overall Compliance: No
		Severity Score: 8.75

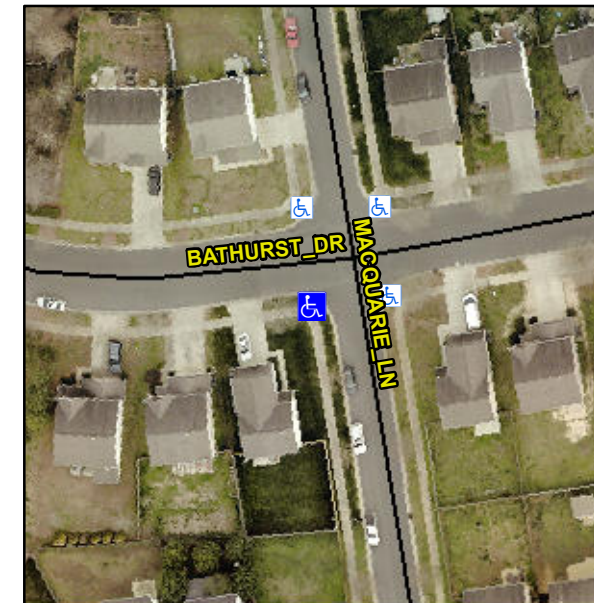
Not Found, R304.5.1

Compliance	Description	Data	Compliance	Description	Data
N/A	Ramp Length (in)	69.0	Yes	Ramp Slope (%)	5.2
No	Ramp Width (in)	45.5	Yes	Ramp XSlope (%)	1.2
N/A	Flare Type LT	N/A	N/A	Flare Type RT	N/A
N/A	Flare Slope LT (%)	N/A	N/A	Flare Slope RT (%)	N/A
N/A	Flare Traversable LT?	N/A	N/A	Flare Traversable RT?	N/A
N/A	Landing Length (in)	N/A	N/A	DWS Provided?	N/A
N/A	Landing Width (in)	N/A	N/A	DWS Contrast?	N/A
N/A	Landing Slope (%)	N/A	N/A	DWS Length (in)	N/A
N/A	Landing X Slope (%)	N/A	N/A	DWS Full Width?	N/A
N/A	Landing Curb? (Y/N)	N/A	N/A	DWS Offset (in)	N/A
N/A	Shared Landing?	N/A			
N/A	Gutter Ponding?	N/A	N/A	Gutter Slope (%)	N/A
N/A	Gutter Lip Ht (in)	N/A	N/A	Gutter X Slope (%)	N/A
N/A	Painted X Walk1?	No	N/A	Painted X Walk2?	No
	X Walk 1 Direction	To E		X Walk 2 Direction	To N
N/A	X Walk 1 Width (in)	N/A	N/A	X Walk 2 Width (in)	N/A
	X Walk 1 Slope (%)	3.4		X Walk 2 Slope (%)	5.0
	X Walk 1 X Slope (%)	1.2		X Walk 2 X Slope (%)	3.8

N/A	Ramp inside XWalk1?	N/A	N/A	Ramp inside XWalk2?	N/A
	Road Slope (%)	1.0	N/A	Clear Space?	N/A
	Road X Slope (%)	5.9	N/A	Clear Space to XWalk (in)	N/A
N/A	Any Obstructions?	N/A	N/A	Storm Grate/Utility Hazard?	N/A
	Obstruction Type			Storm Grate/Utility Type	
		N/A			N/A
			Yes	Surface Condition? (G/P)	Good

Possible Solutions:

Remove & Replace Curb Ramp With Two New Directional Ramps or Equivalent.
